Trail Development Plan

Bundaberg Gin Gin Rail Trail

January 2019

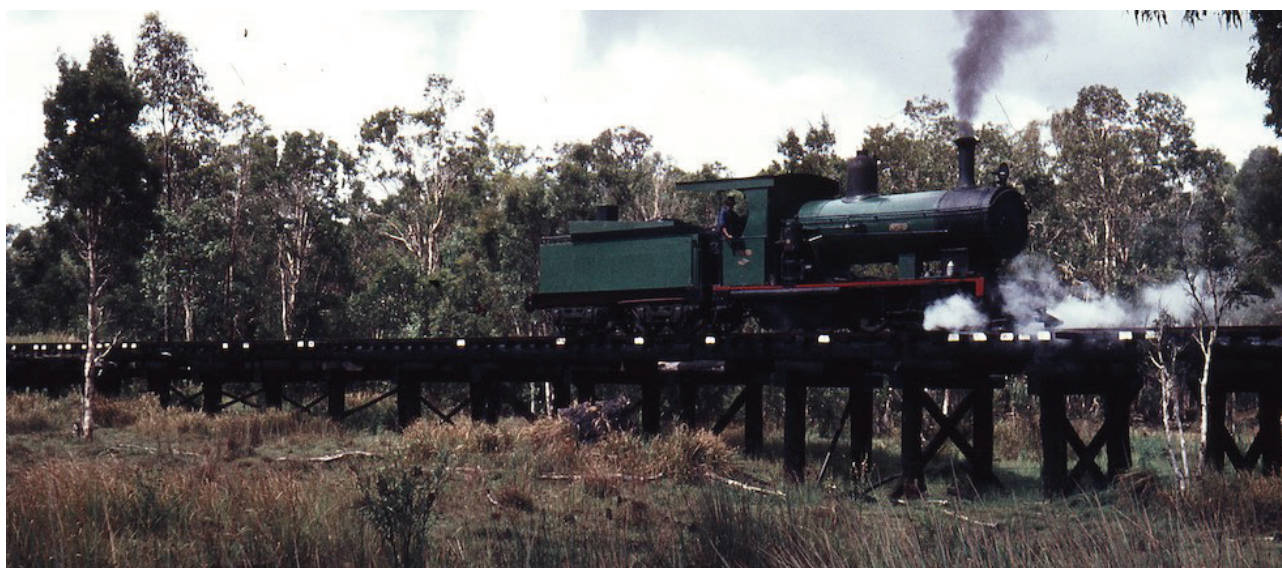
This bridge near Bingera Siding was typical of the 40 “flood openings” on the railway between Bundaberg and Gin Gin. Replacement of these missing structures will be a major cost component of the development of the proposed rail trail.

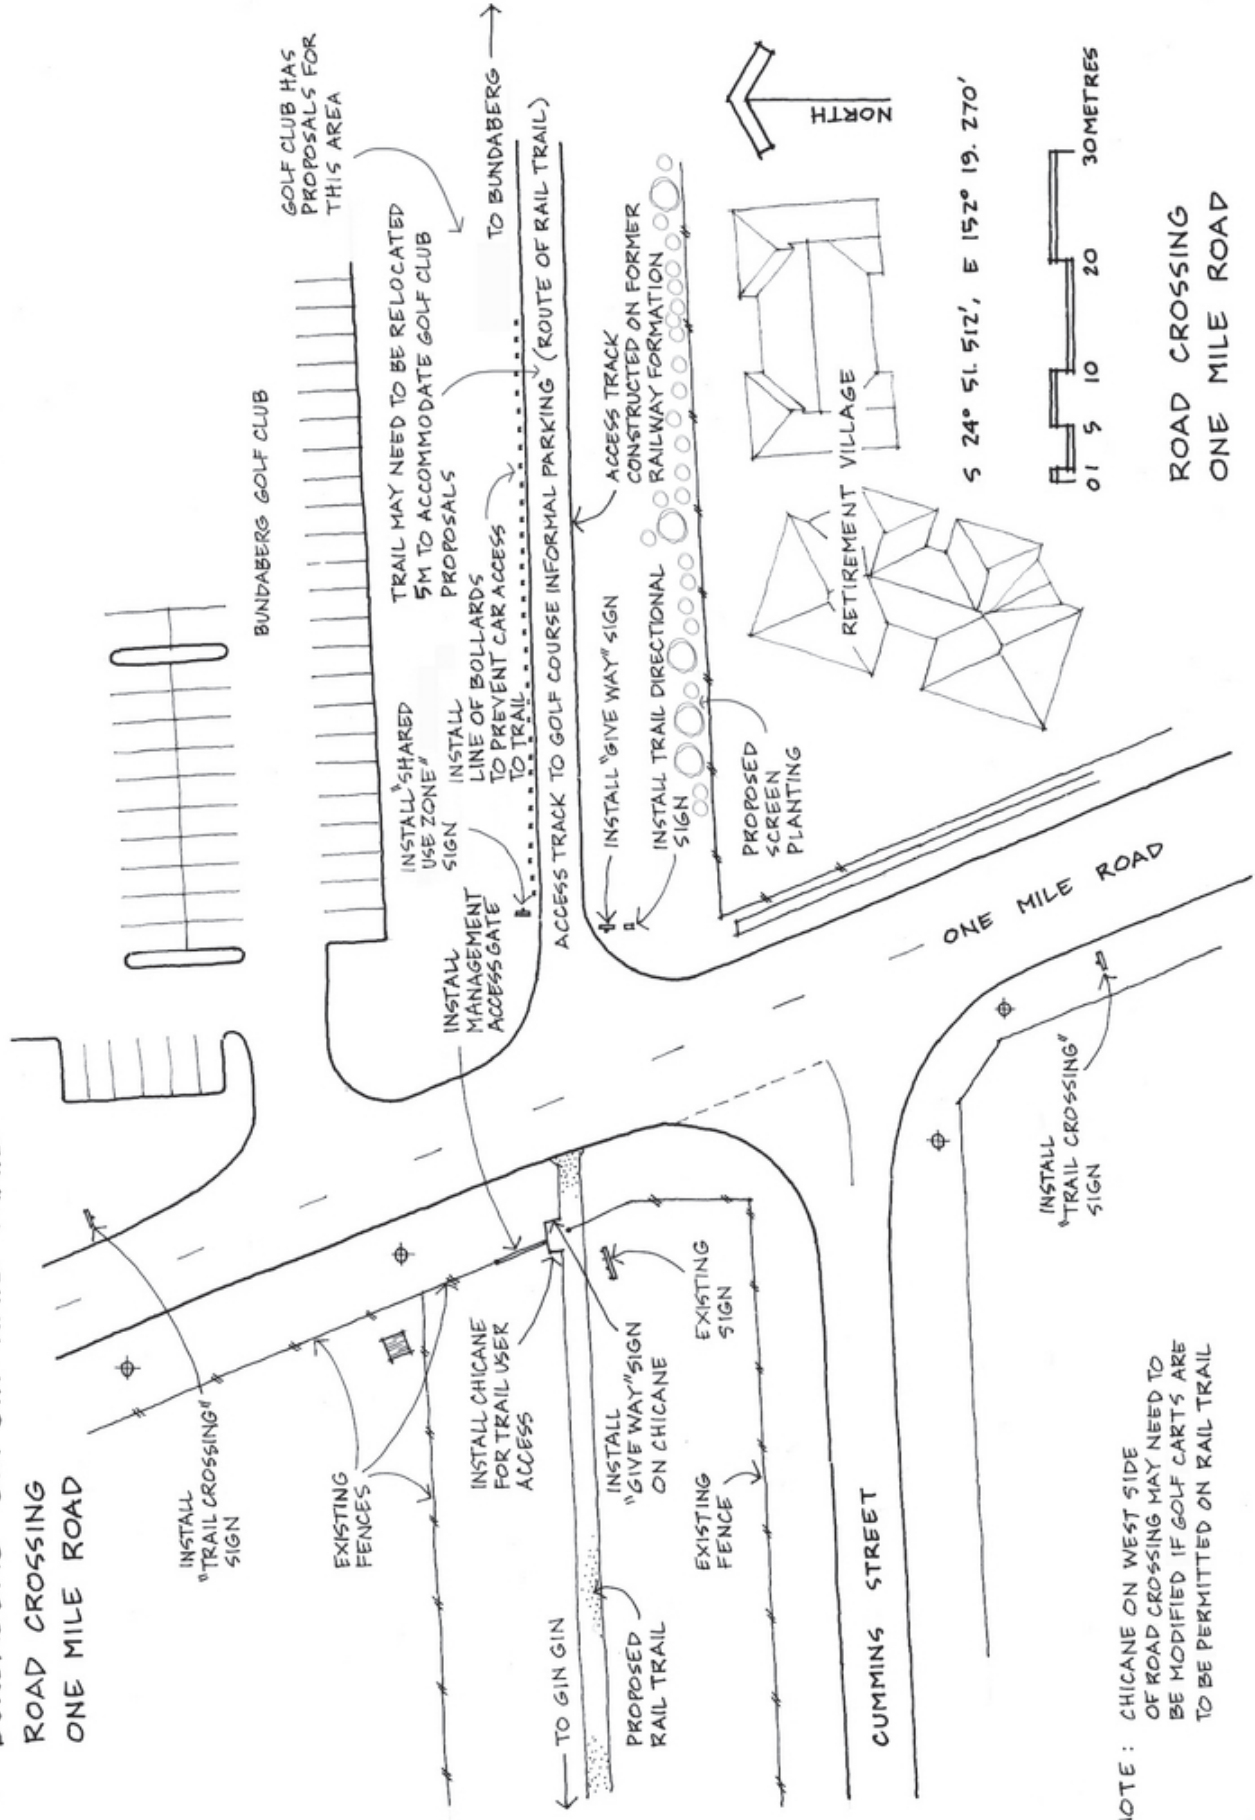
**BUNDABERG GIN GIN RAIL TRAIL
ROAD CROSSING
ONE MILE ROAD**

NOTE : CHICANE ON WEST SIDE OF ROAD CROSSING MAY NEED TO BE MODIFIED IF GOLF CARTS ARE TO BE PERMITTED ON RAIL TRAIL

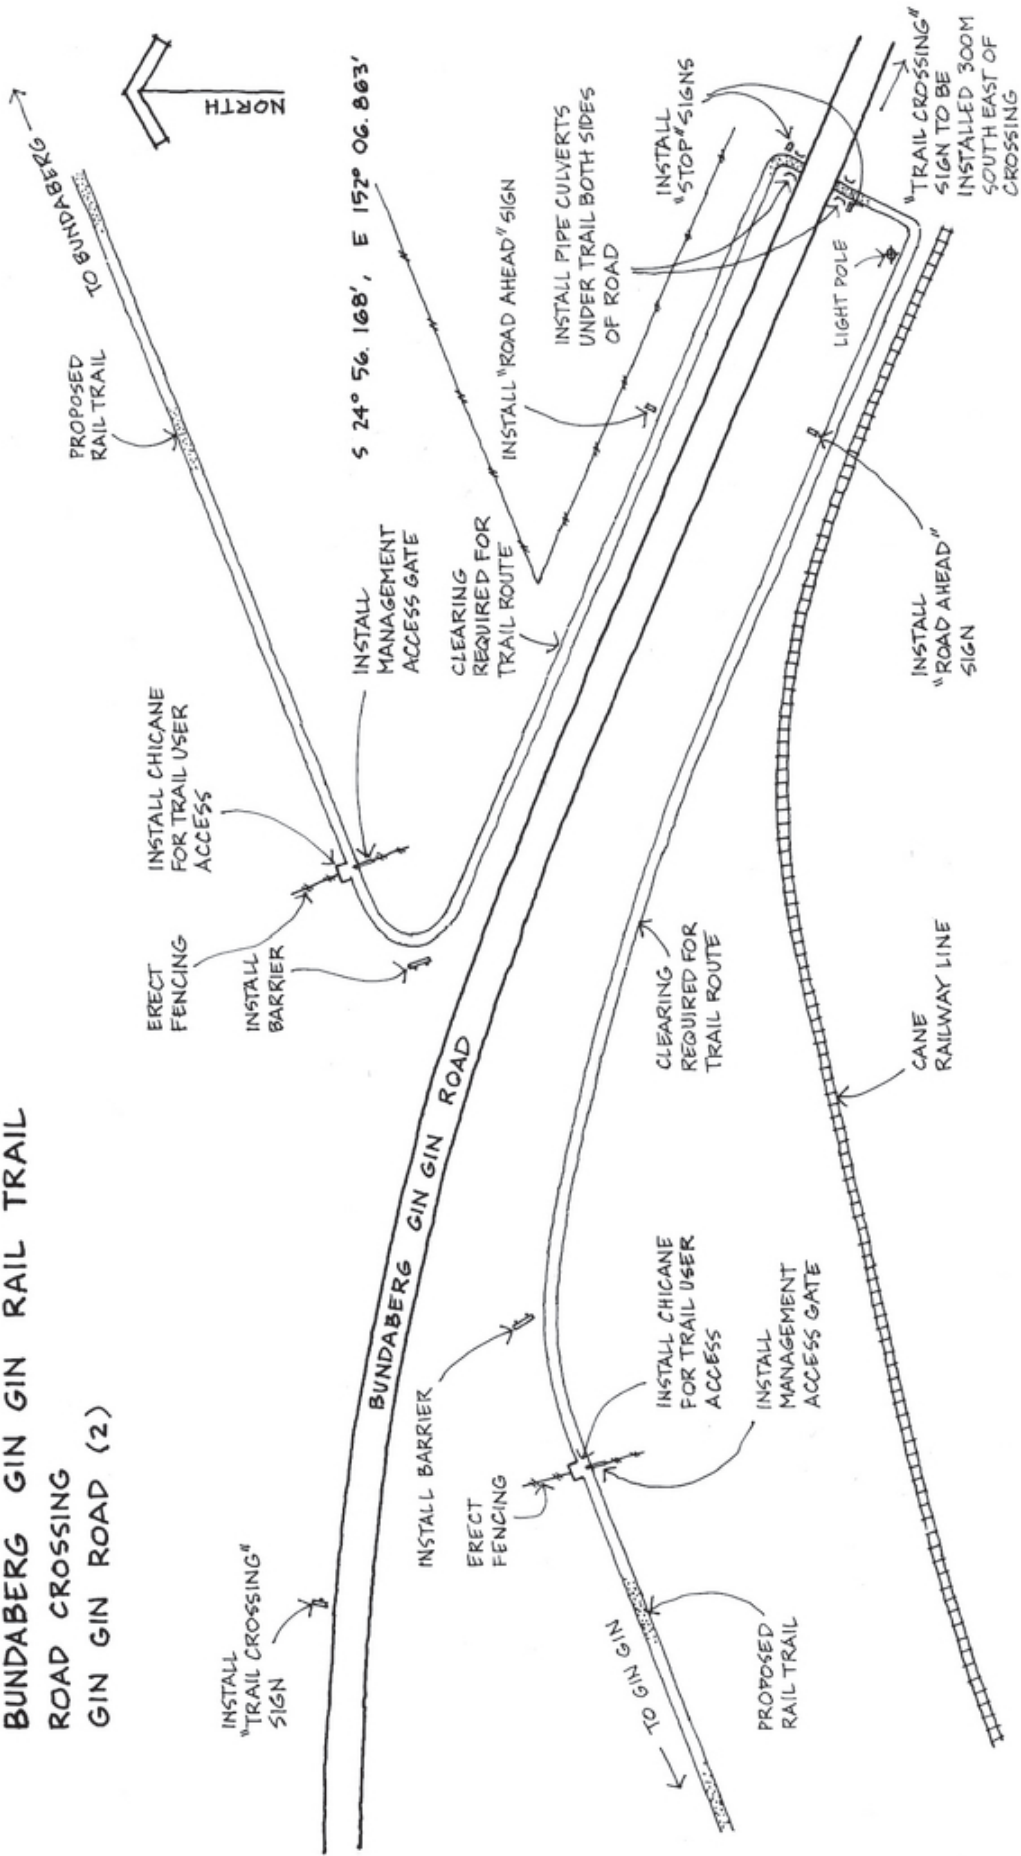
BUNDABERG GIN GIN RAIL TRAIL ROAD CROSSING GIN GIN ROAD (2)

NOTE:
ROAD CROSSING LOCATION CHOSEN TO
MAXIMISE SIGHT LINES IN BOTH DIRECTIONS.
TRAIL ROUTE UTILISES ROAD RESERVE ON
BOTH SIDES OF BUNDABERG GIN GIN ROAD.

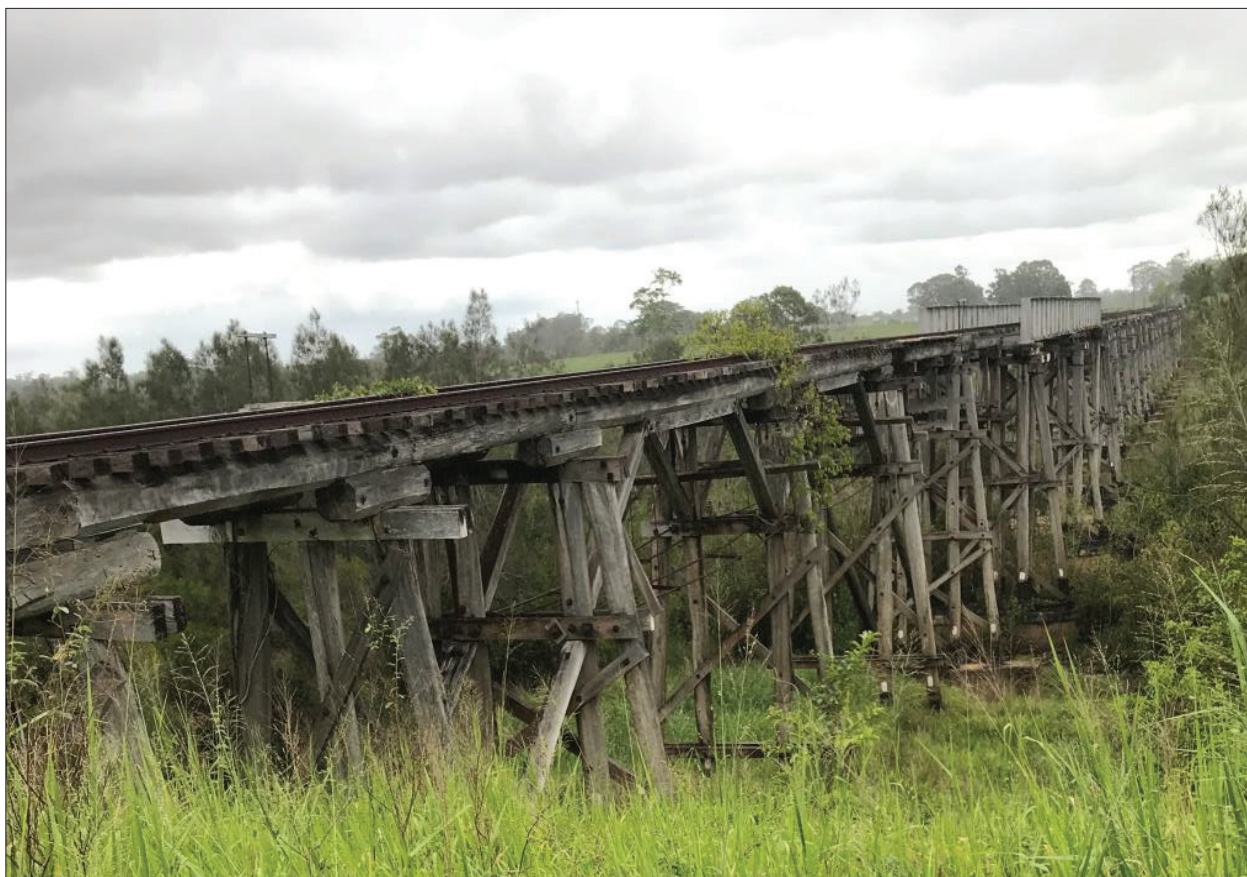
Figure 2-1: View of Splitters Creek Bridge from end 1. There is 7 timber approach spans on Side 1 (Eastern Side) of the creek which is spanned by 2 continuous steel through plate girders supported by a centre timber bent (trestle) in the creek. There is a large amount of vegetation growth around the timber bents which keeps the moisture content high in the timber. When the moisture level in the timber is above 22%, decay-causing fungi can start to grow; when the moisture content drops below this level, the fungi become dormant and decay will be arrested until the moisture content rises again.

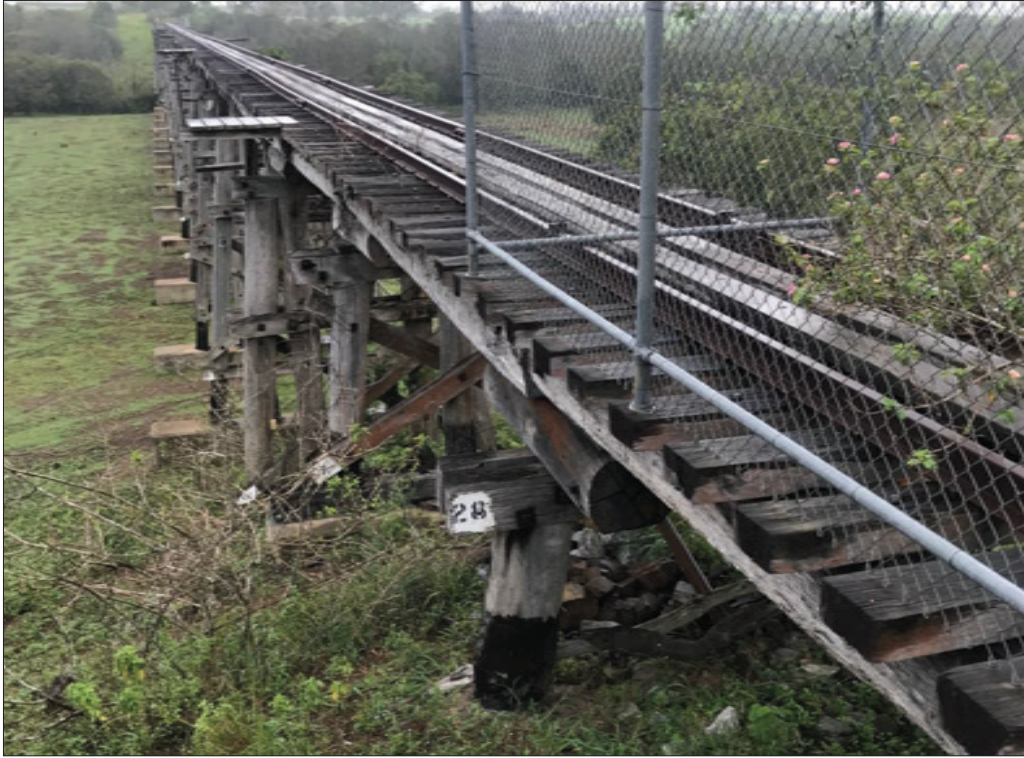
Figure 2-2: View of Splitters Creek Bridge from end 2. There is 18 timber approach spans on Side 2 (Western Side) of the creek. Unlike side 1, the vegetation is quite low and clear under and around the bridge as cattle continually graze this area. Note Bent 1 consists of driven timber piles (Pile Bent), while the remaining bents of this side are constructed from timber posts bearing directly on a concrete footing (Frame Bent). Note the fence to prevent pedestrian or vehicle traffic.

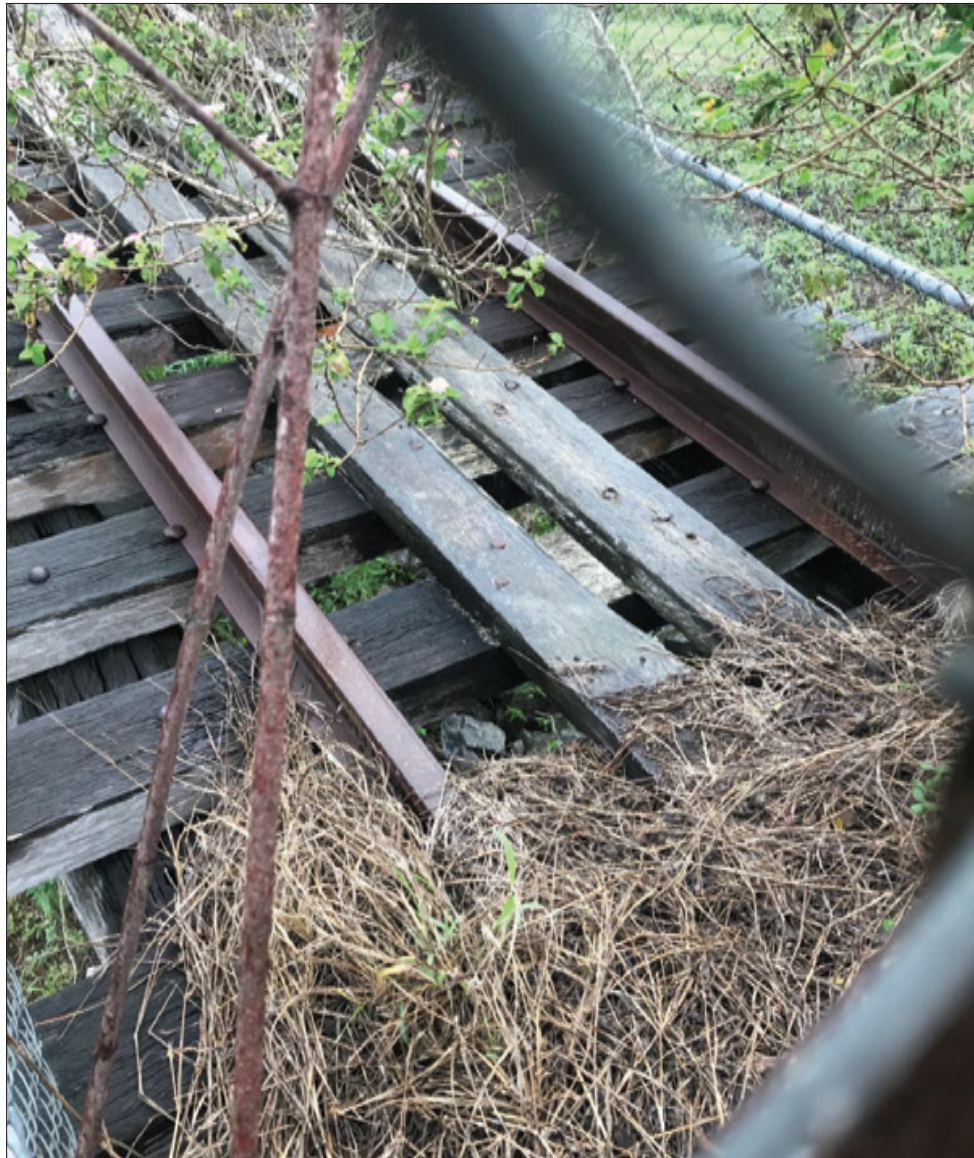
Figure 2-4: Close-up view of the transoms and the condition of the girders from the top.

Overall the timbers members appear in a fair condition and it seems a large amount of restoration works were completed just prior to the railway line closing in 1993, 26 years ago. However, with the high density of vertical through bolts suggest that there might be decay within the members or lead to decay in the near future once the ‘natural durability’ of the hardwood depletes. Vertical fasteners increase the rate of decay in timber as they allow moisture to travel down the fastener into the heartwood of the girders and corbels where evaporation is more difficult, therefore increasing the moisture content in the middle of these elements over longer periods of time. The heartwood of a log element is less capable of breathing and expelling moisture than the sapwood that surrounds it, so vertical connectors funnel the moisture directly into the heartwood accelerating decay. Once the moisture content exceeds 22%, timber consuming fungi are activated and the decay process begins. Refer to Figure 4-2 for a detailed description of how and where the decay occurs due to these vertical bolts.

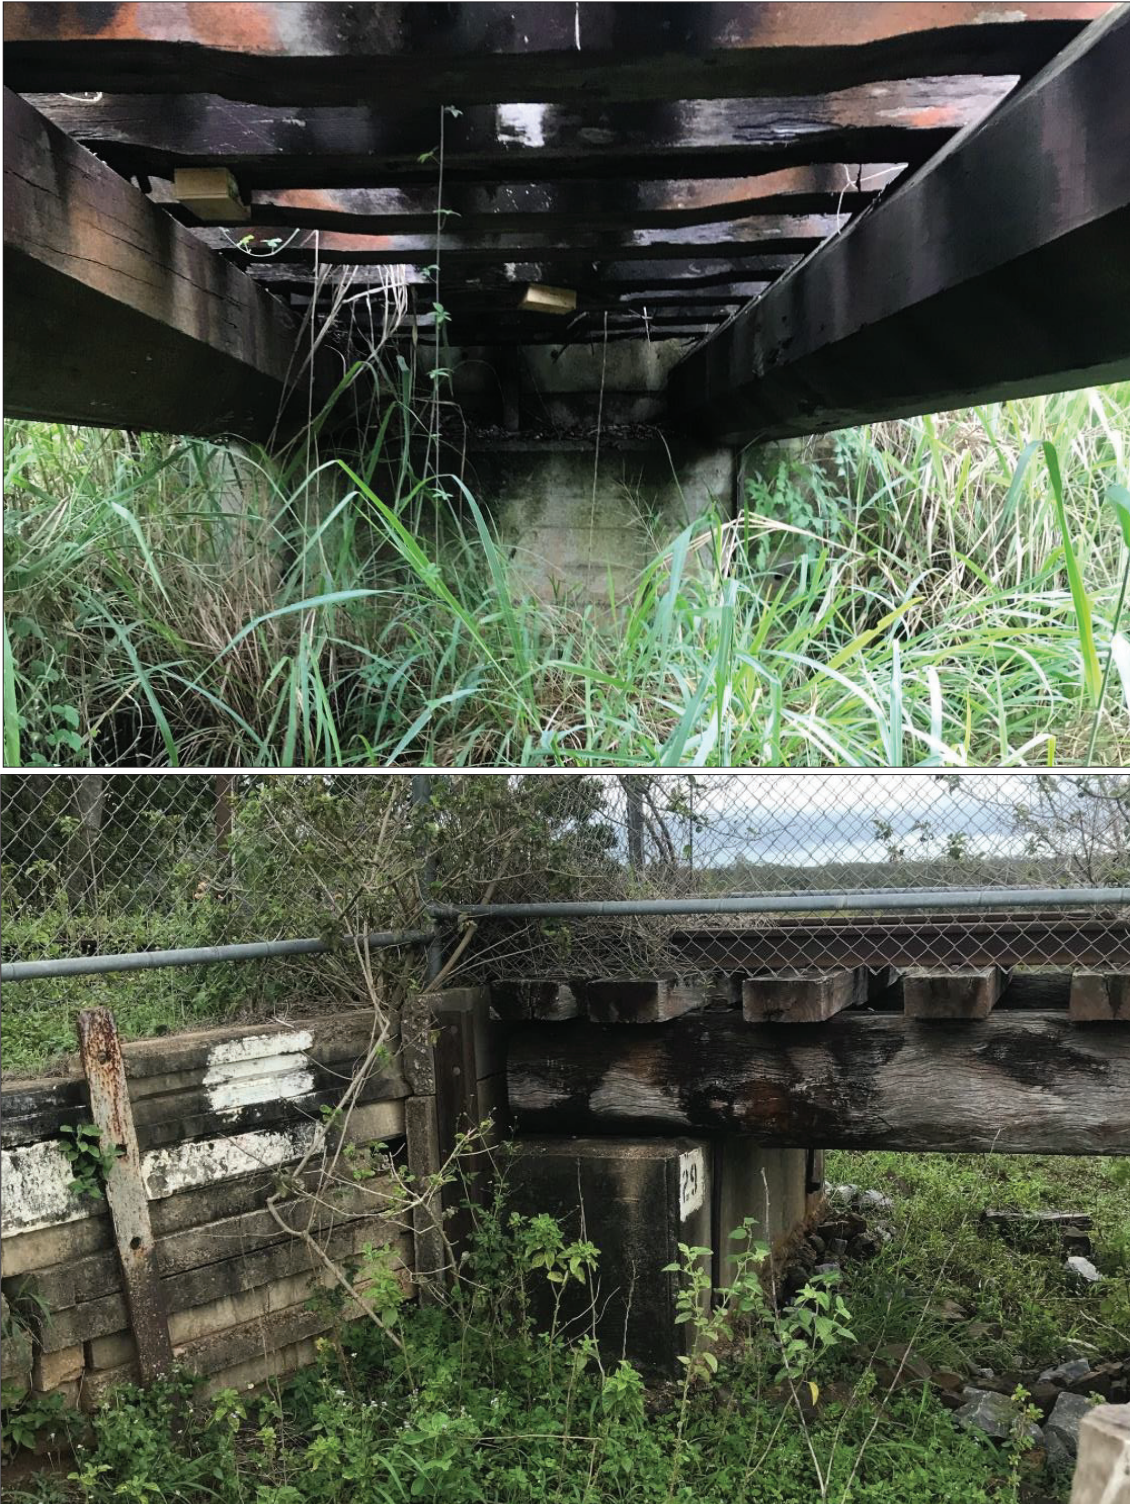
Figure 2-5: View of both abutments, Abutment 1 on top and Abutment 2 the bottom image. Both abutments are concrete piers with the wingwalls consisting of concrete panels held in place by sections of the steel railway line. This is a typical abutment configuration for this period of railway construction and is a testament to the original construction and should be retained as they are in fair condition.

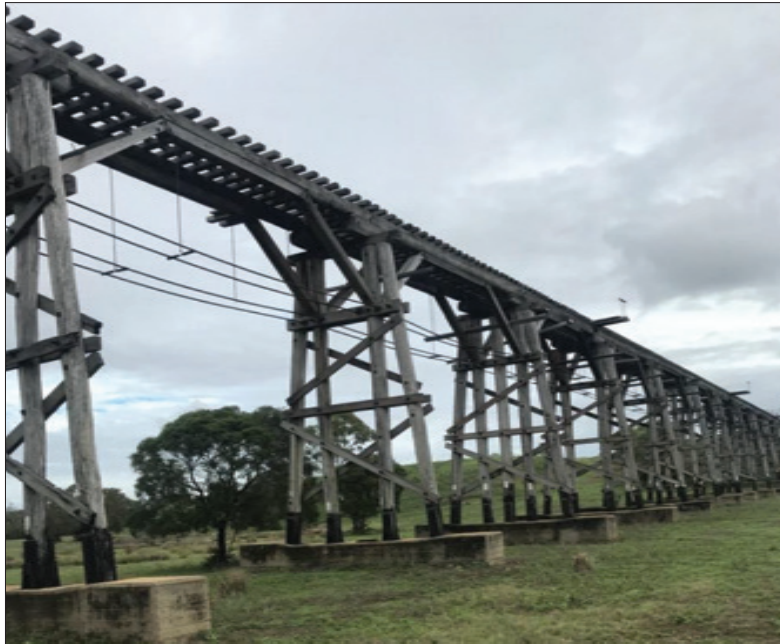
Figure 2-6: An overall view of the timber approach spans of side 2 from the creek bed. The 11m long girders are supported by struts (knee braces) attached to the frame bents which effectively reduces the span length and helps transfer the load from the superstructure (girders) into the substructure (posts). This allows smaller (more accessible at the time) girders to span a longer length and keep the number of bents down as they would have been a large percentage of the overall cost of the bridge. The girders bear directly on corbels which sit on the headstocks. The headstocks transfer the load into the 4 posts (some posts have 5 posts) and down into the concrete spread footing. The timber sashes (horizontal braces) and cross bracing provides lateral support for the tall bents. The full length shoes for the knee brace attachment to the girders is an interesting design not typical of the period.

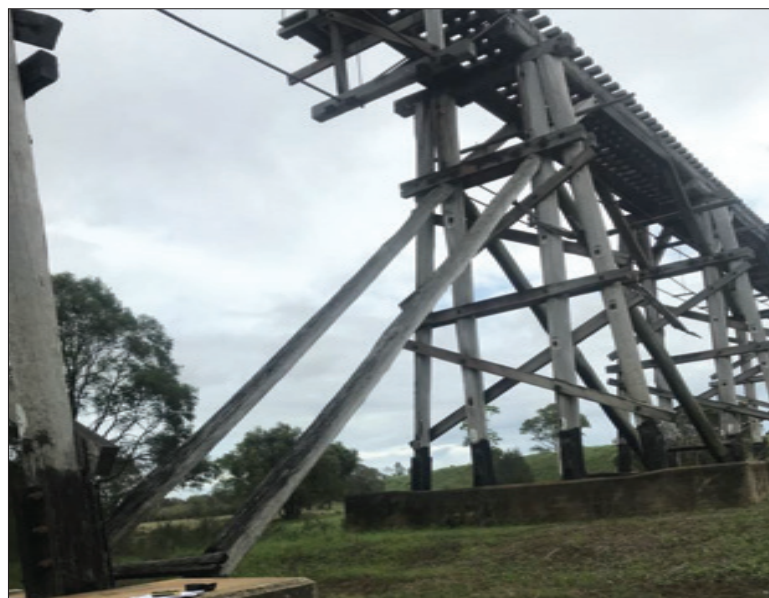
Figure 2-7: Several of the bents have log longitudinal bracing that extends from the concrete base of one bent to the top sash of the bent being supported. This bracing is repeated on the other side of the bent. This type of stability repair is seen in two other locations along the bridge.

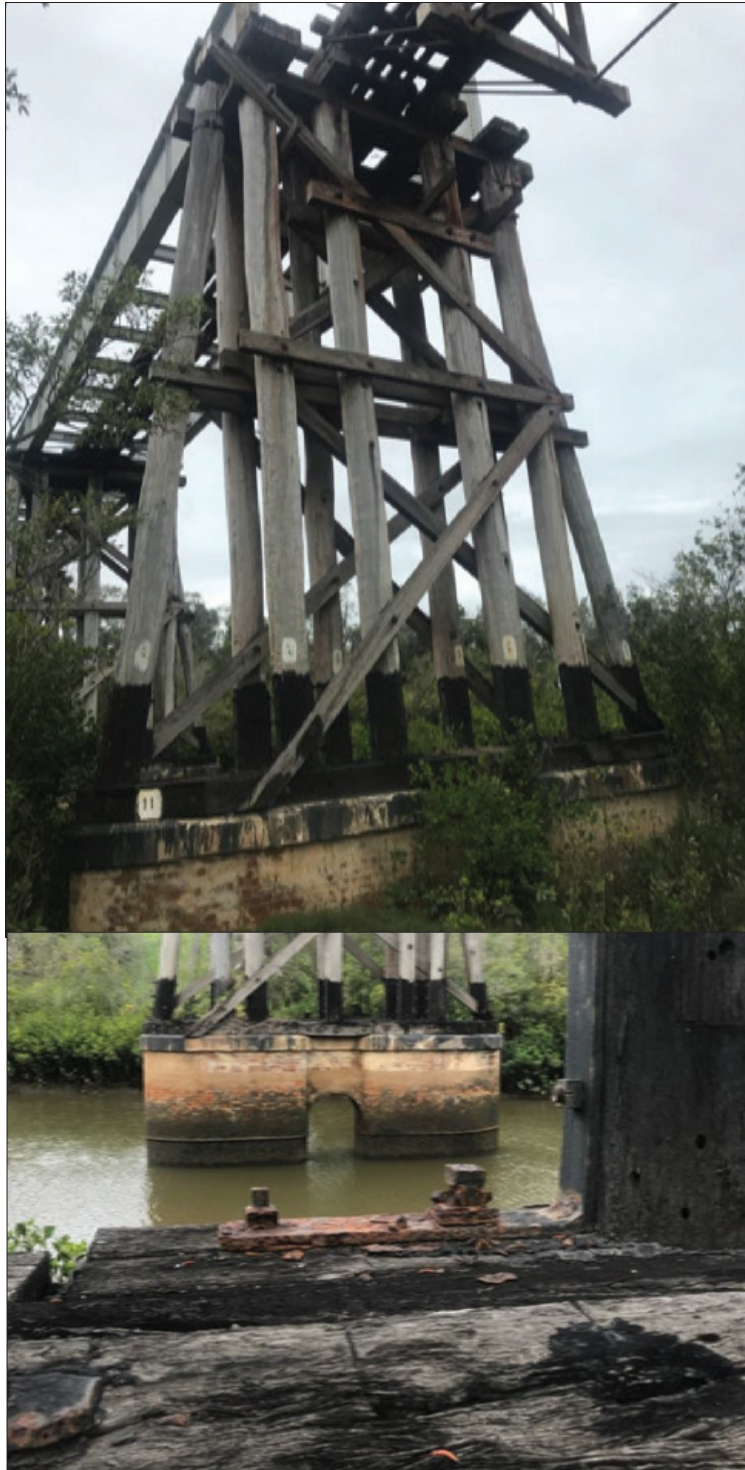
Figure 2-8: There are three larger timber frame bents that support the two steel plated girder spans over Splitters Creek. These bents consist of 12 timber posts that bear on timber cap wales that help distribute the load into the concrete footings. Overall these bents are visually in fair condition and are very significant to the heritage of the structure. Note the black coal tar coating applied to the bottoms of the columns. This coal tar paint holds the moisture into the bottoms of the columns and the moisture absorbed from the concrete below is not able to evaporate. This is an old method of heavy timber bridge construction that actually shorted the timber component life. Diffusing these areas would be important to preserve and extend the life of the element.

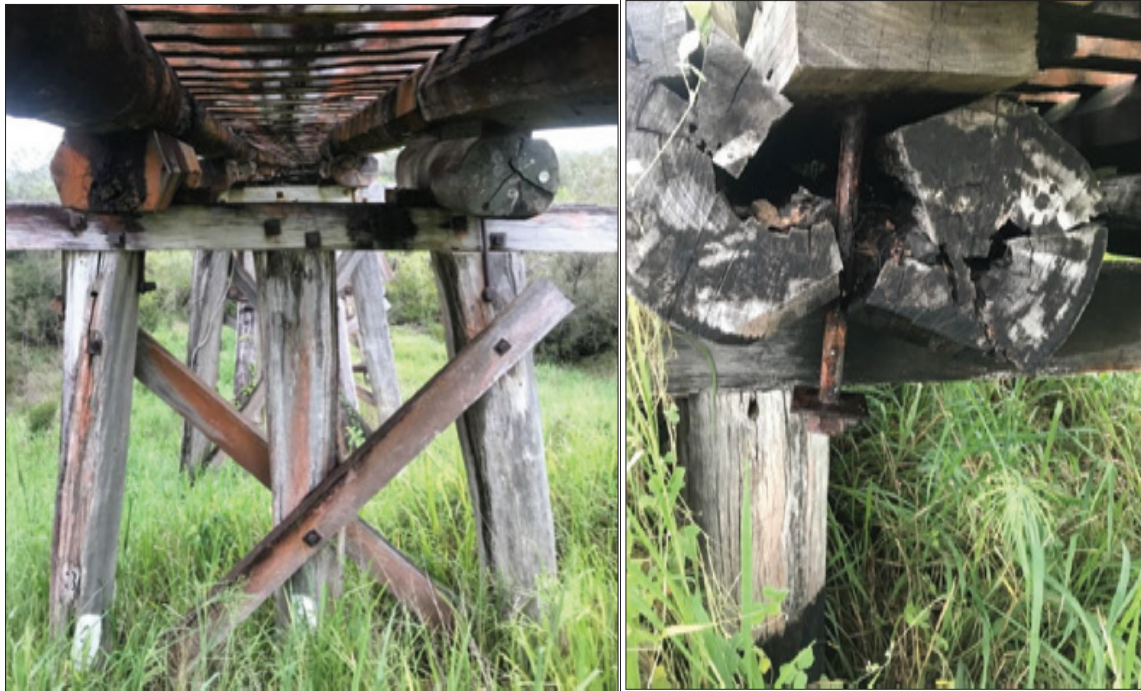
Figure 2-9: View of one of the pile bents on approach 1 side of the creek. This bent consist of three driven piles and overall in fair condition. Most of the corbels in these bents are in fair condition, however there was only one corbel found that had crushed and failed due to the vertical through bolt allowing moisture in which lead to the member decaying.

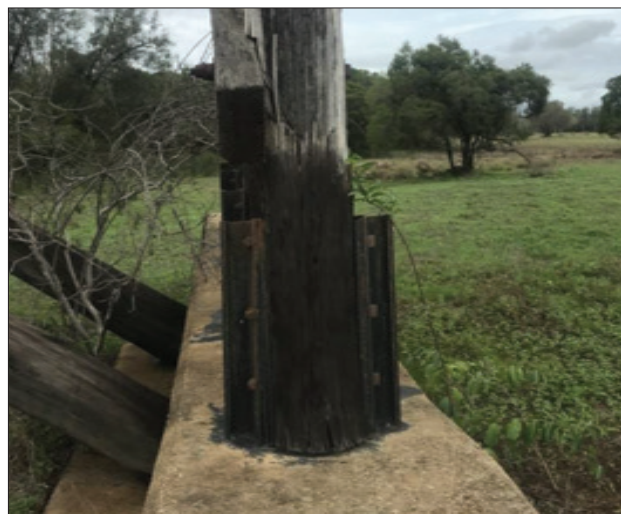
Figure 2-10: The typical detail of the post hold down connection is two large steel plates (railway line) embedded into the concrete footing that connects to the timber post with 6 horizontal bolts. As shown in Figures 2-11 & 2-12 below, the bottom section of several posts have moderately to severely undergone decay. This is as per expected due to the timber posts bearing directly on the concrete footing which typically has a high moisture content. Over time the timber post undergoes capillary action and draws up the moisture like a ‘straw’. Once the moisture content in the timber elements reaches 22%, decay causing fungi are activated and the decay process begins. The heavy solids coating on the column bottoms has further increased the moisture retention problem by preventing the element from breathing and reaching equilibrium moisture contents below the point at with decay begins and proceeds (22%).

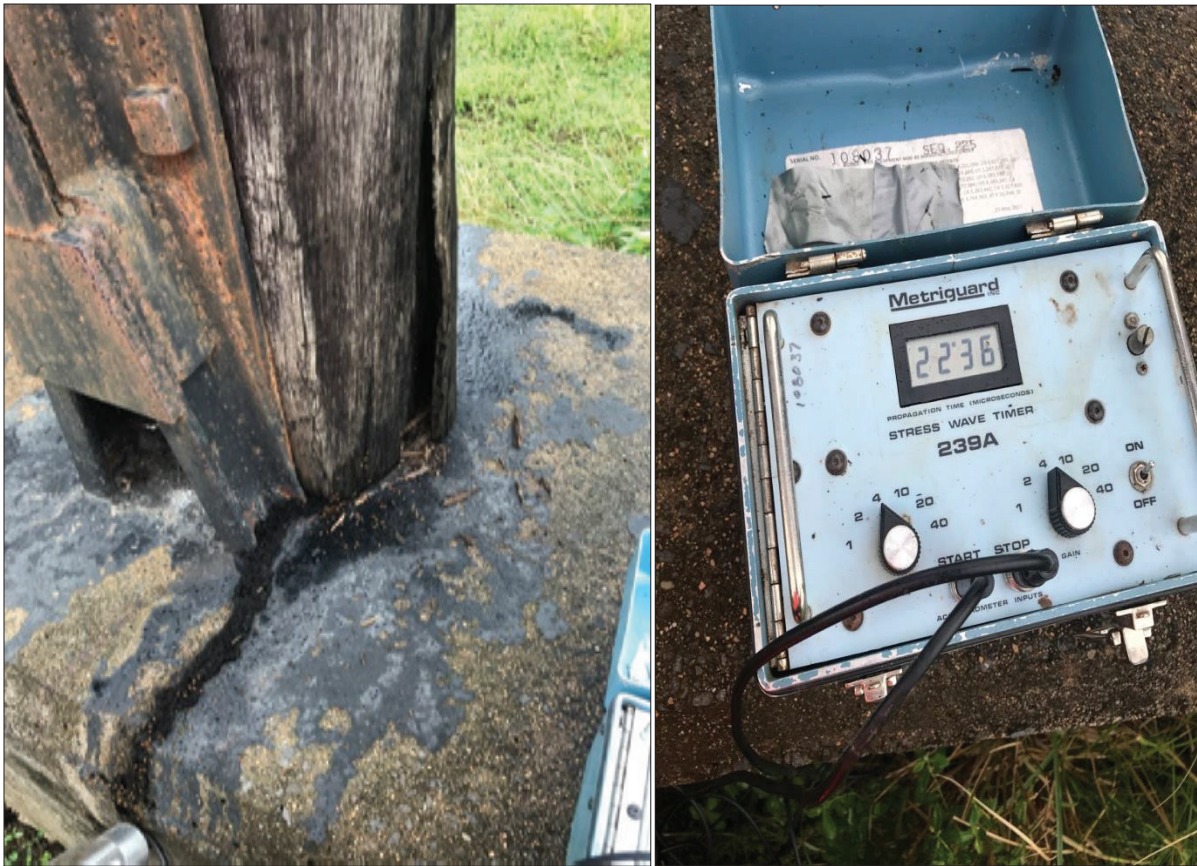
Figure 2-11: As described above, the bottom sections of the timber posts were determined to be a ‘hotspot’ for decay and determined to be an ideal area to test using non-destructive methods, such as EPHOD® Stress Wave Technology. Refer to Appendix A for more information of this type of testing method. The reading of 2236 μ s recorded is the time taken for the compression wave to travel across the section of the member tested. This was recorded at the bottom of one of the posts and was found to be similar across 25% of the posts. Deterioration of this magnitude means that the Modulus of Elasticity/Modulus of Rupture in various stress directions (wood is anisotropic with different strength properties in different directions) has deteriorated to an extent that the element can no longer support its own dead weight. Readings between 1000 μ s and 2200 μ s indicate that the member cannot carry its own dead weight in these regions. Readings in excess of 2200 μ s can signify a cavity while a reading above 3300 μ s indicates the element can no longer support its own dead load and is at risk of failing at any point. It can also be noted that roughly 1m above the concrete footing the post had readings around 600 μ s which signifies sound (solid) wood resulting in only the bottom portions requiring require. It is highly recommended to conduct a detailed inspection of the entire substructure utilizing non-destructive technology through the use of the Stress Wave Timer (SWT) machine. Also note that termites were found at this particular location and it’s unknown how many other areas of the structure are affected. It is estimated that 25% of the posts will require repair at the bottom 1m section of the post and 10% will require full repair/replacement. Refer to Section 5 for a full list of recommended repair options for refurbishment to a pedestrian/cycle bridge.

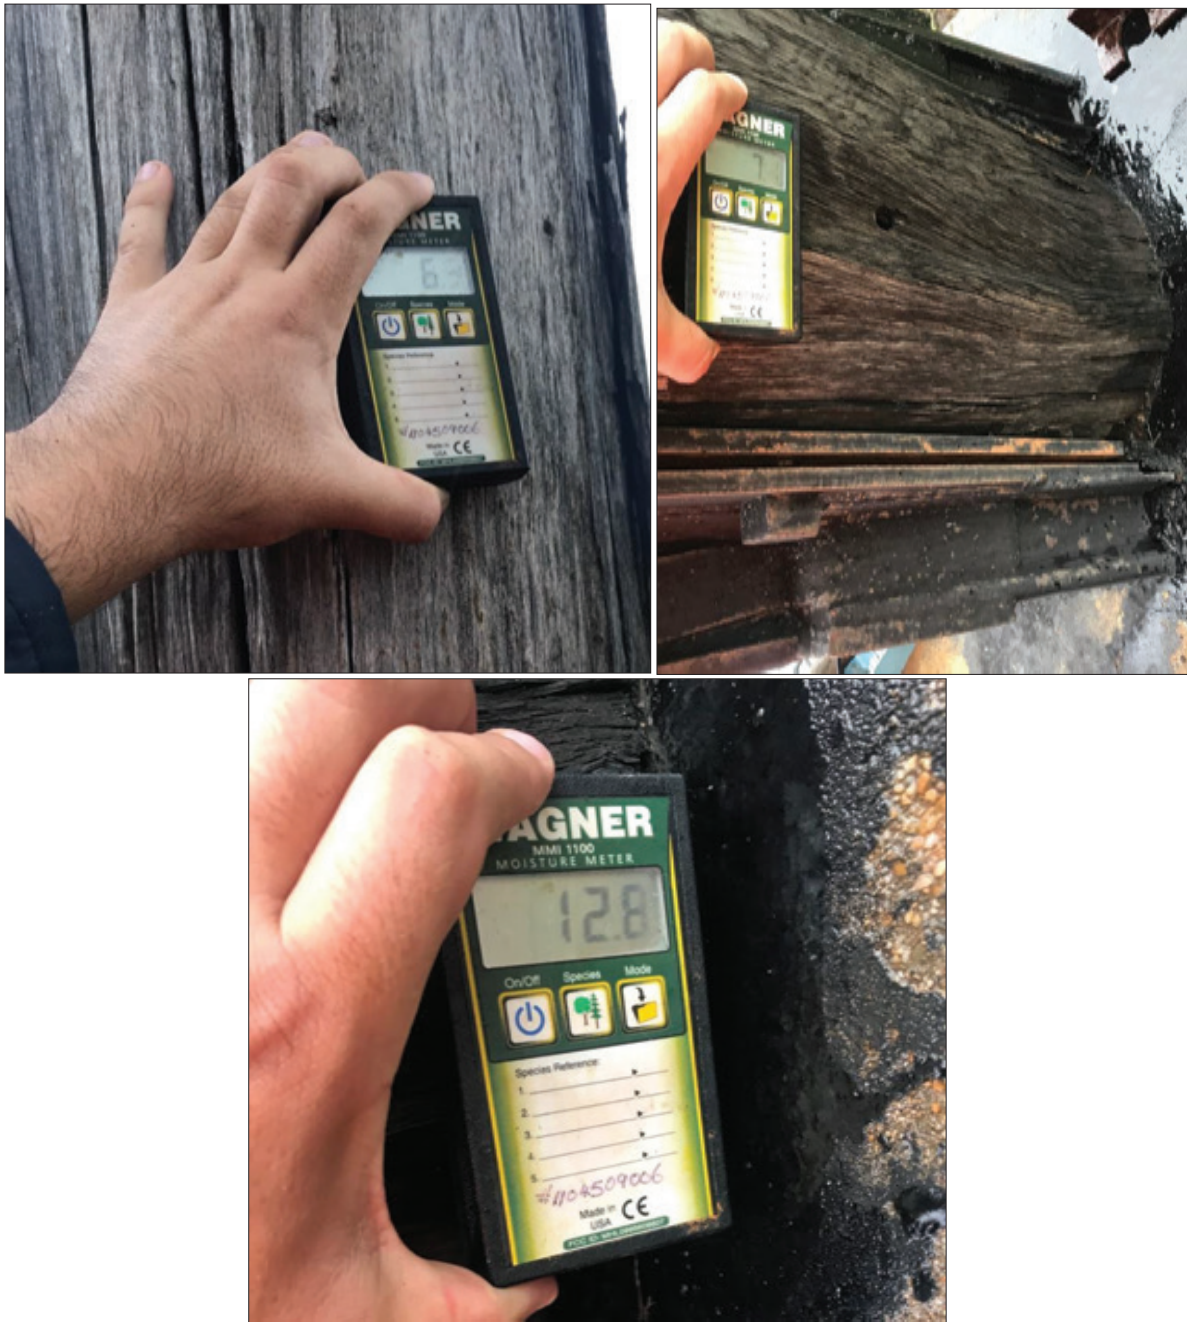
Figure 2-12: As mentioned previously and proved in the three images above, the moisture content (MC) of the timber post is higher in the timber element closer to the ‘saturated’ concrete footing. The 6.3% MC is measured roughly 1m up from the footing, the 7.1% reading was 0.5m from the bottom and the highest reading of 12.8% MC reading was just above the concrete footing.

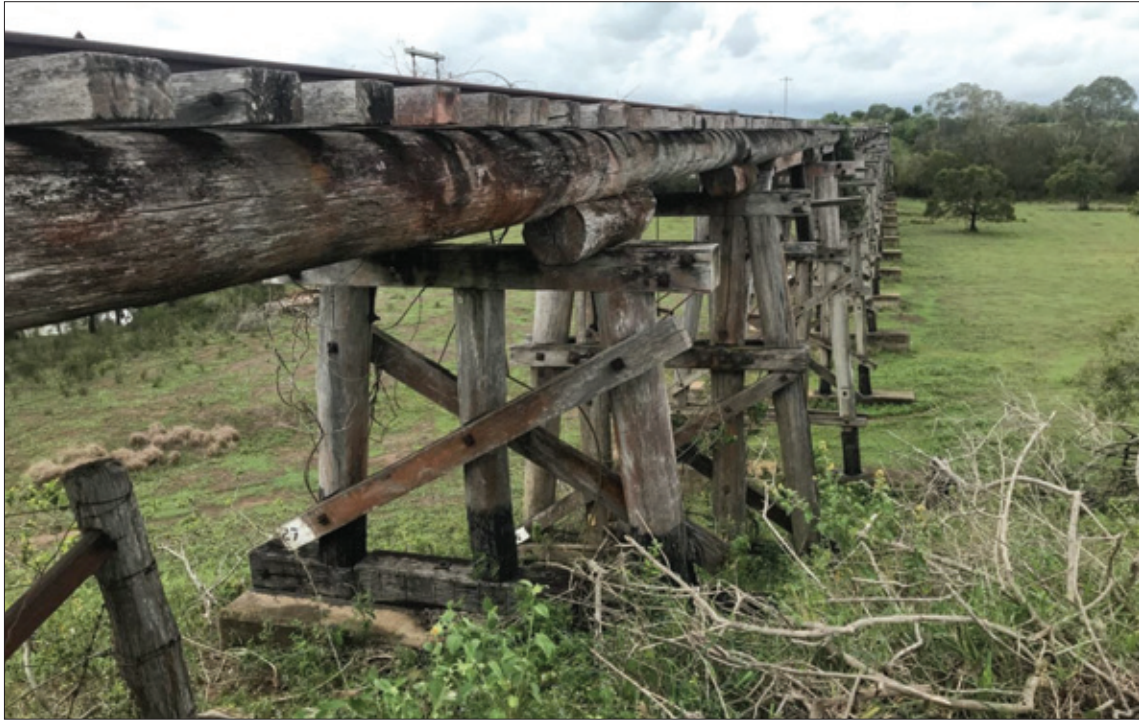
Figure 2-13: The girders and corbels of the two lower spans at Abutment 2 end was also briefly tested with the SWT machine. The adjusted values of most of the readings did not exceed 700 microseconds. This suggests that the timber at the locations tested is still in fair condition and will be suitable for use in carrying pedestrian loadings. However this is only a small sample size and it is highly recommended to conduct a detailed inspection of the entire superstructure using of the SWT machine. As mentioned previously the vertical fasteners that connect these members together increase the rate of decay in timber as they allow moisture to travel down the fastener into the heartwood of the girders and corbels, therefore increasing the moisture content in the middle of these elements. The heartwood of a log element is less capable of breathing and expelling moisture than the sapwood that surrounds it, so vertical connectors funnel the moisture directly into the heartwood accelerating decay. Once the moisture content exceeds 22%, timber consuming fungi are activated and the decay process begins. It is estimated that 10% of the corbels and girders will require repair/replacement. Refer to Section 5 for a full list of recommended repair options for refurbishment to a pedestrian/cycle bridge.

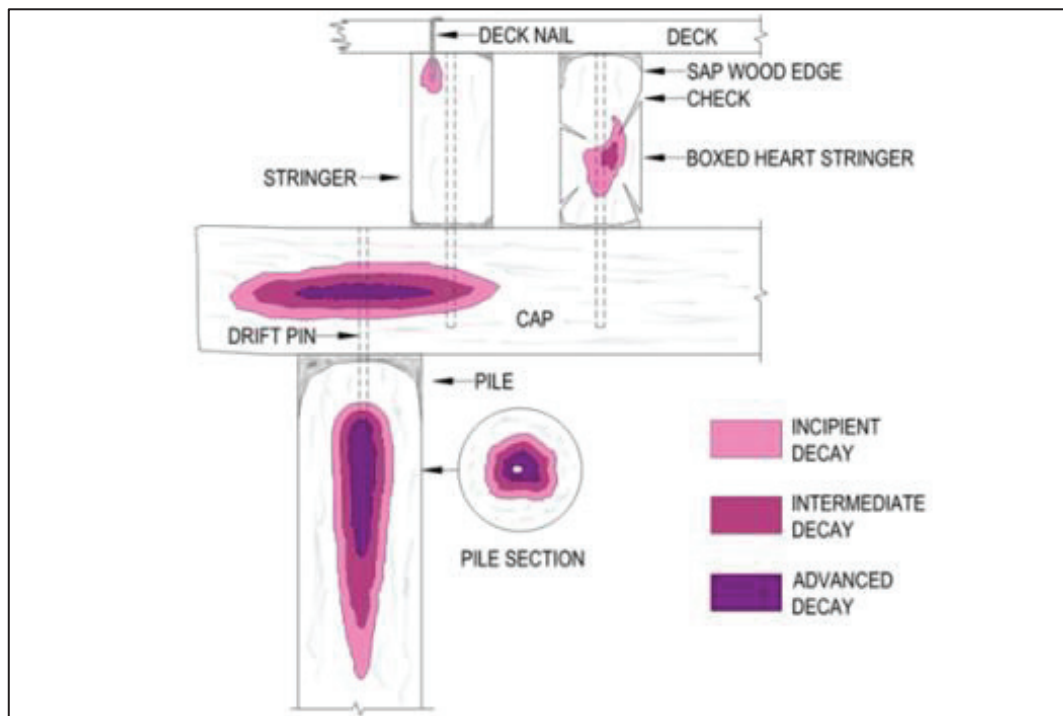
Figure 4-2: Shows the level of decay that occurs in timber due to the use of vertical fasteners. Vertical fasteners increase the rate of decay in timber as they allow moisture to travel down the fastener into the heartwood of the headstock (cap), girders (stringers), corbels and piles, therefore increasing the moisture content in the middle of these elements. The heartwood of a log element is less capable of breathing and expelling moisture than the sapwood that surrounds it, so vertical connectors funnel the moisture directly into the heartwood accelerating decay. Once the moisture content exceeds 22%, timber consuming fungi are activated and the decay process begins.
