Subject Drainage Issues at No. 177 Tantitha Road, Gooburrum **Personal Information**

1. Introduction

Following a meeting with **Personal Information** (No. 177 Tantitha Road, Gooburrum) on the 11th of September 2018, a high level drainage study of the Tantitha Creek catchment area has been undertaken. The purpose of the drainage study has been to investigate the effects of clearing the overgrown vegetation and widening the open drain downstream of the major culverts crossing Fairymead Road.

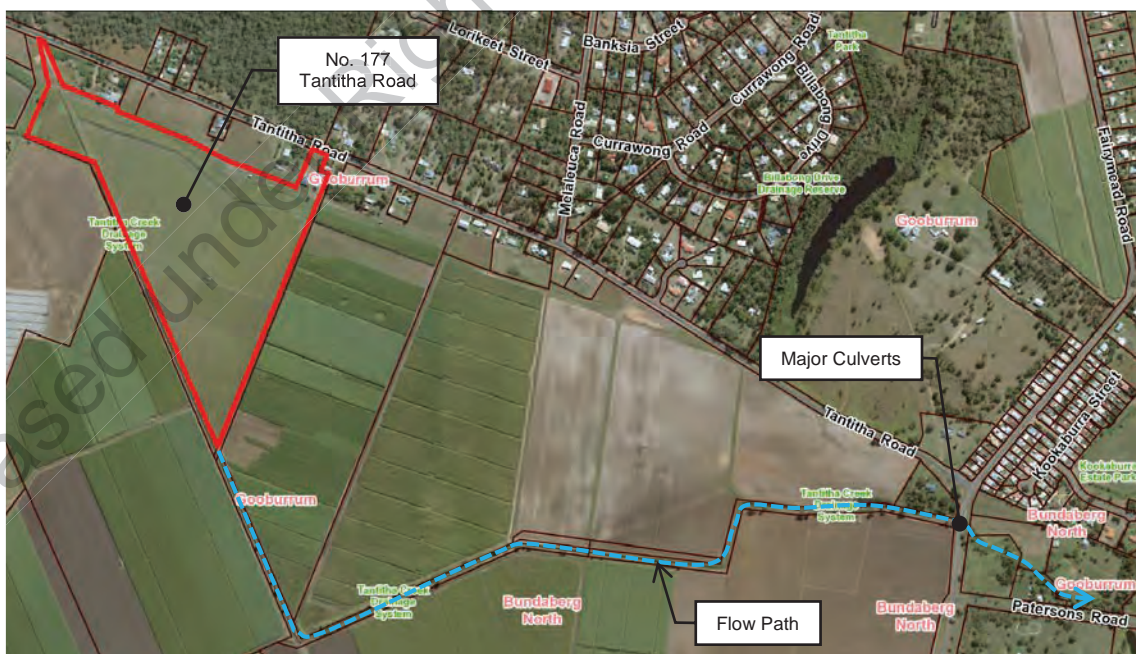
Figure 1 – Property Locality

Council has received numerous complaints from the owners of No. 177 Tantitha Road regarding longstanding water within their property following periods of significant rainfall. The owners of No. 177 Tantitha Road, **Personal Information**, claim that a large portion of their property is inundated for many days, causing damage to cattle pastures and fencing. The owners have suggested that free drainage of the property is inhibited by overgrown vegetation and narrowing of the flow path within the large open drain on the downstream side of the major culverts crossing Fairymead Road. The location of the property and its proximity to the major culverts beneath Fairymead Road is shown below in Figure 1.

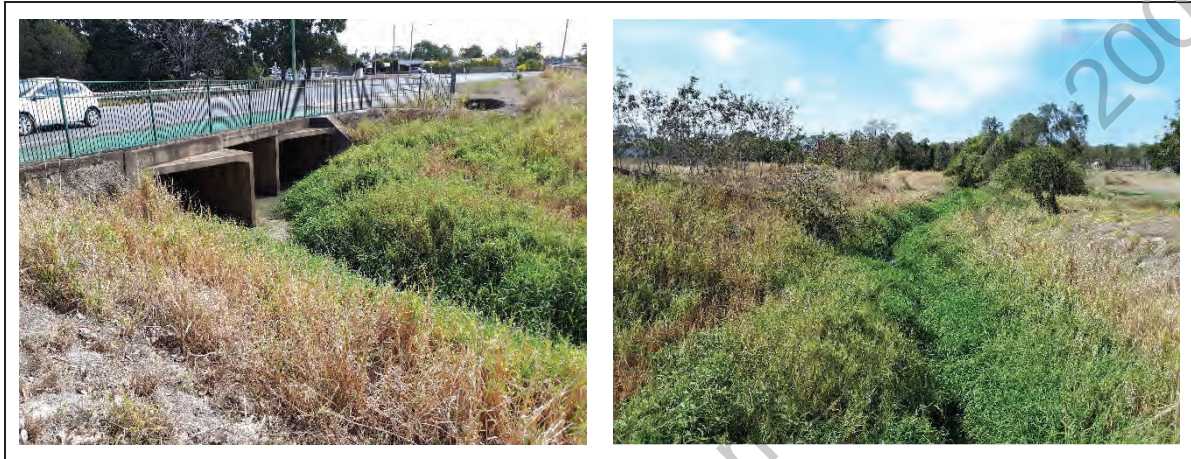
Photos taken in September 2018 shown below in Figure 2 demonstrate the overgrown vegetation and narrowed flow path downstream of the major culverts. Figure 3 below provides photos at the upstream side of the major culverts.

Figure 2 – Photos: Downstream of Fairymead Road Culverts (September, 2018)

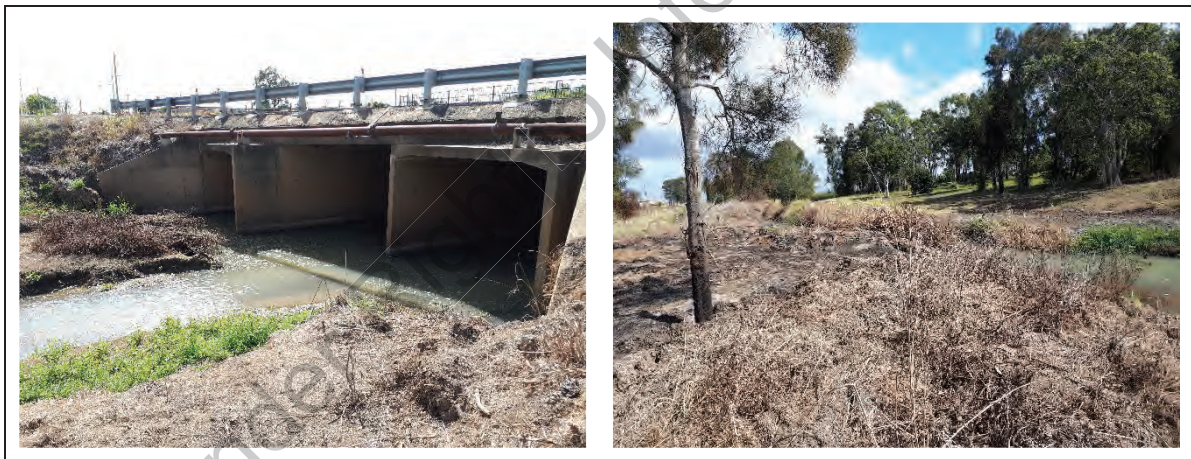
Figure 3 – Photos: Upstream of Fairymead Road Culverts (September, 2018)

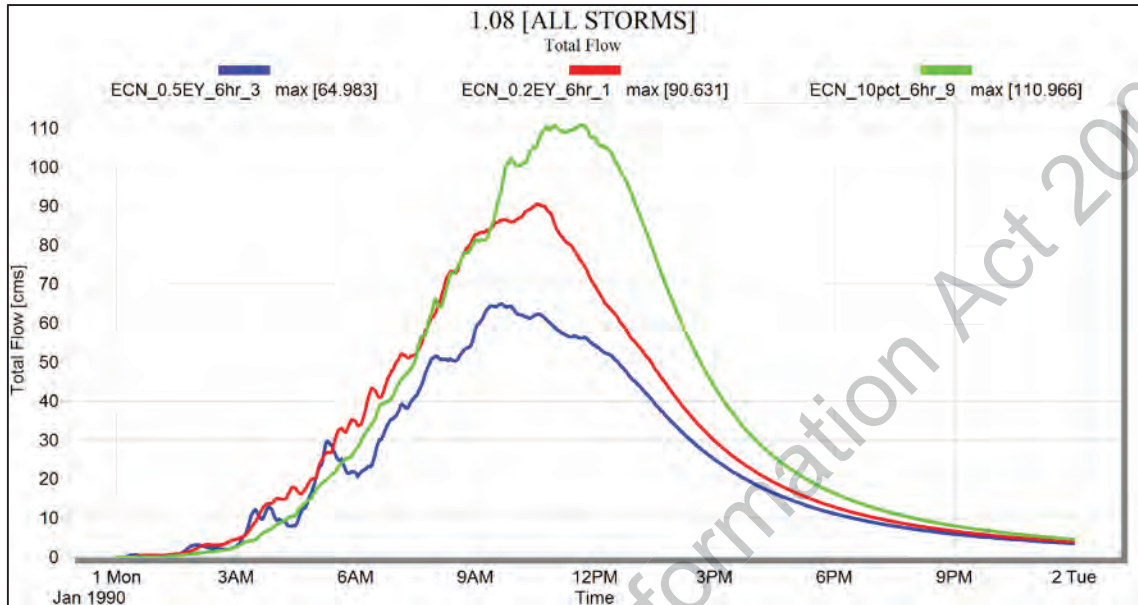
The critical storm hydrographs from the hydrologic model at the major culverts crossing Fairymead Road are shown below in Figure 5.

Figure 5 – Critical Storm Hydrographs at Major Culverts (Fairymead Road)

Hydrologic and hydraulic modelling has been undertaken using the XPRAFTS and XPSWMM software packages respectively. The modelling has been undertaken for the 0.5 EY (2 Year ARI or Q2), 0.2 EY (5 Year ARI or Q5) and the 10% AEP (10 Year ARI or Q10) design storm events using ARR2016 IFD factors, temporal patterns and areal reduction factors. The critical storm duration (peak flow) for each of these design storms is generally 6 hours. From the hydrologic model, a single representative temporal pattern was selected for each design storm to be run within the 2D hydraulic model in accordance with the recommendations in ARR2016 (i.e. mean temporal pattern).

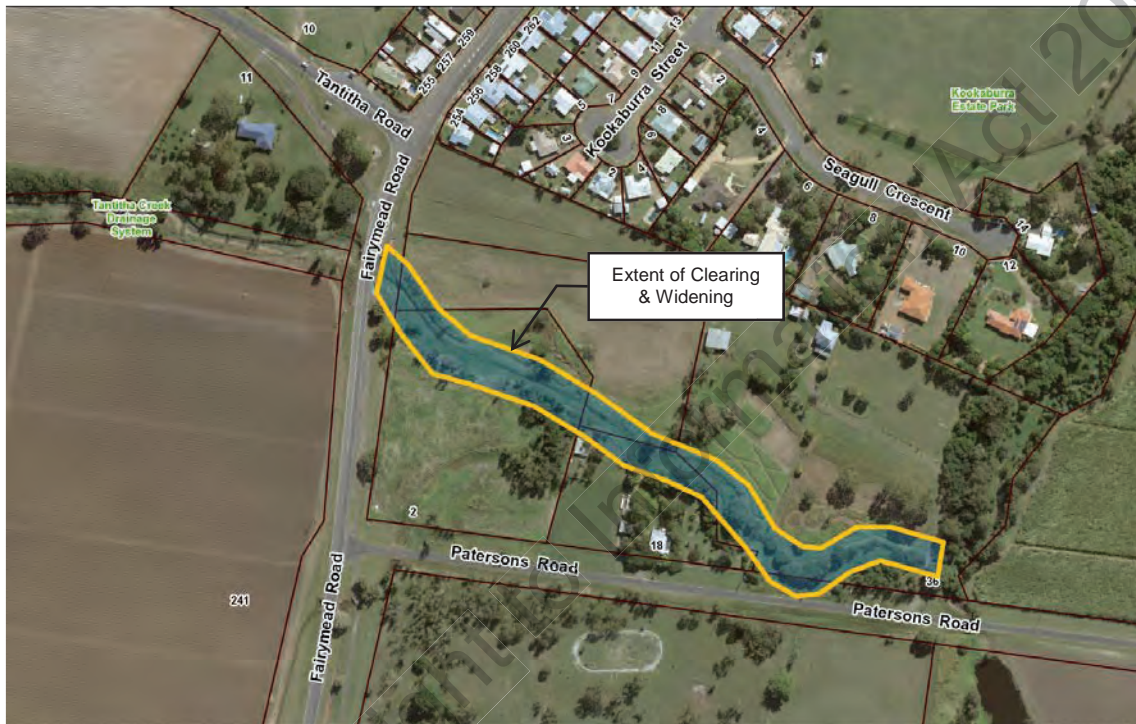
As suggested by the owners of No. 177 Tantitha Road, the upstream effects of clearing the overgrown vegetation and widening the open drain downstream of the major culverts has been investigated. The extents of clearing and widening adopted within the hydraulic model is shown below in Figure 6.

Figure 6 – Drain Clearing and Widening

The hydraulic models developed as part of this high level drainage study indicate that clearing of overgrown vegetation and widening of the open drain downstream of Fairymead Road (Option 1) provides no benefit to No. 177 Tantitha Road. Clearing and widening of this drain over the extents shown in Figure 6 for the purpose of providing benefits to No. 177 Tantitha Road is therefore not recommended.

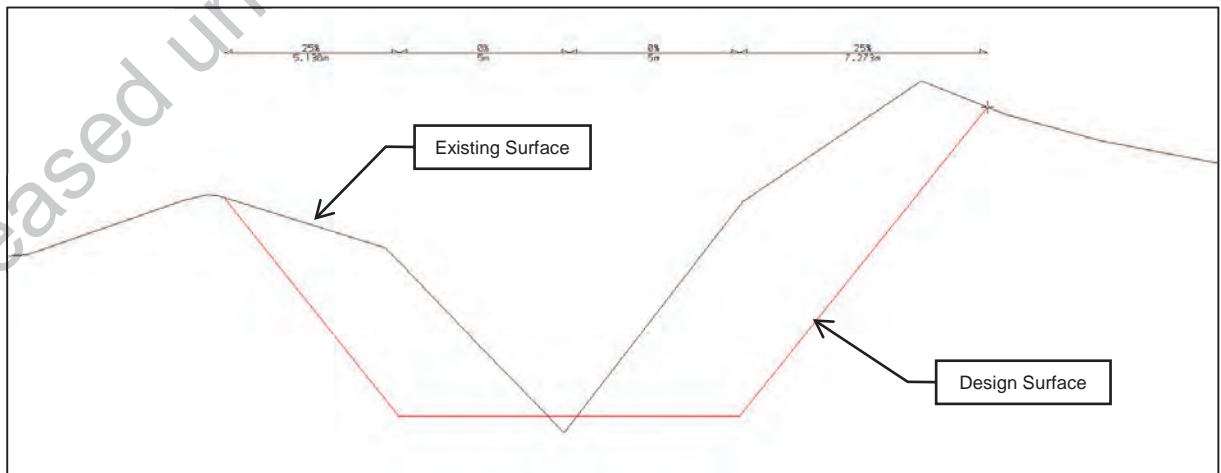
Widening of the open drain has been achieved by adopting a trapezoidal cross section with a 10m wide base and 1 on 4 batters. An example cross section downstream of the major culverts is shown below in Figure 7.

Figure 7 – Option 1 Cross Section

The extent of the widened open drain has also been modelled within the 2D hydraulic model using a Manning's n value of 0.035 to reflect a well maintained drain with minimal vegetation.

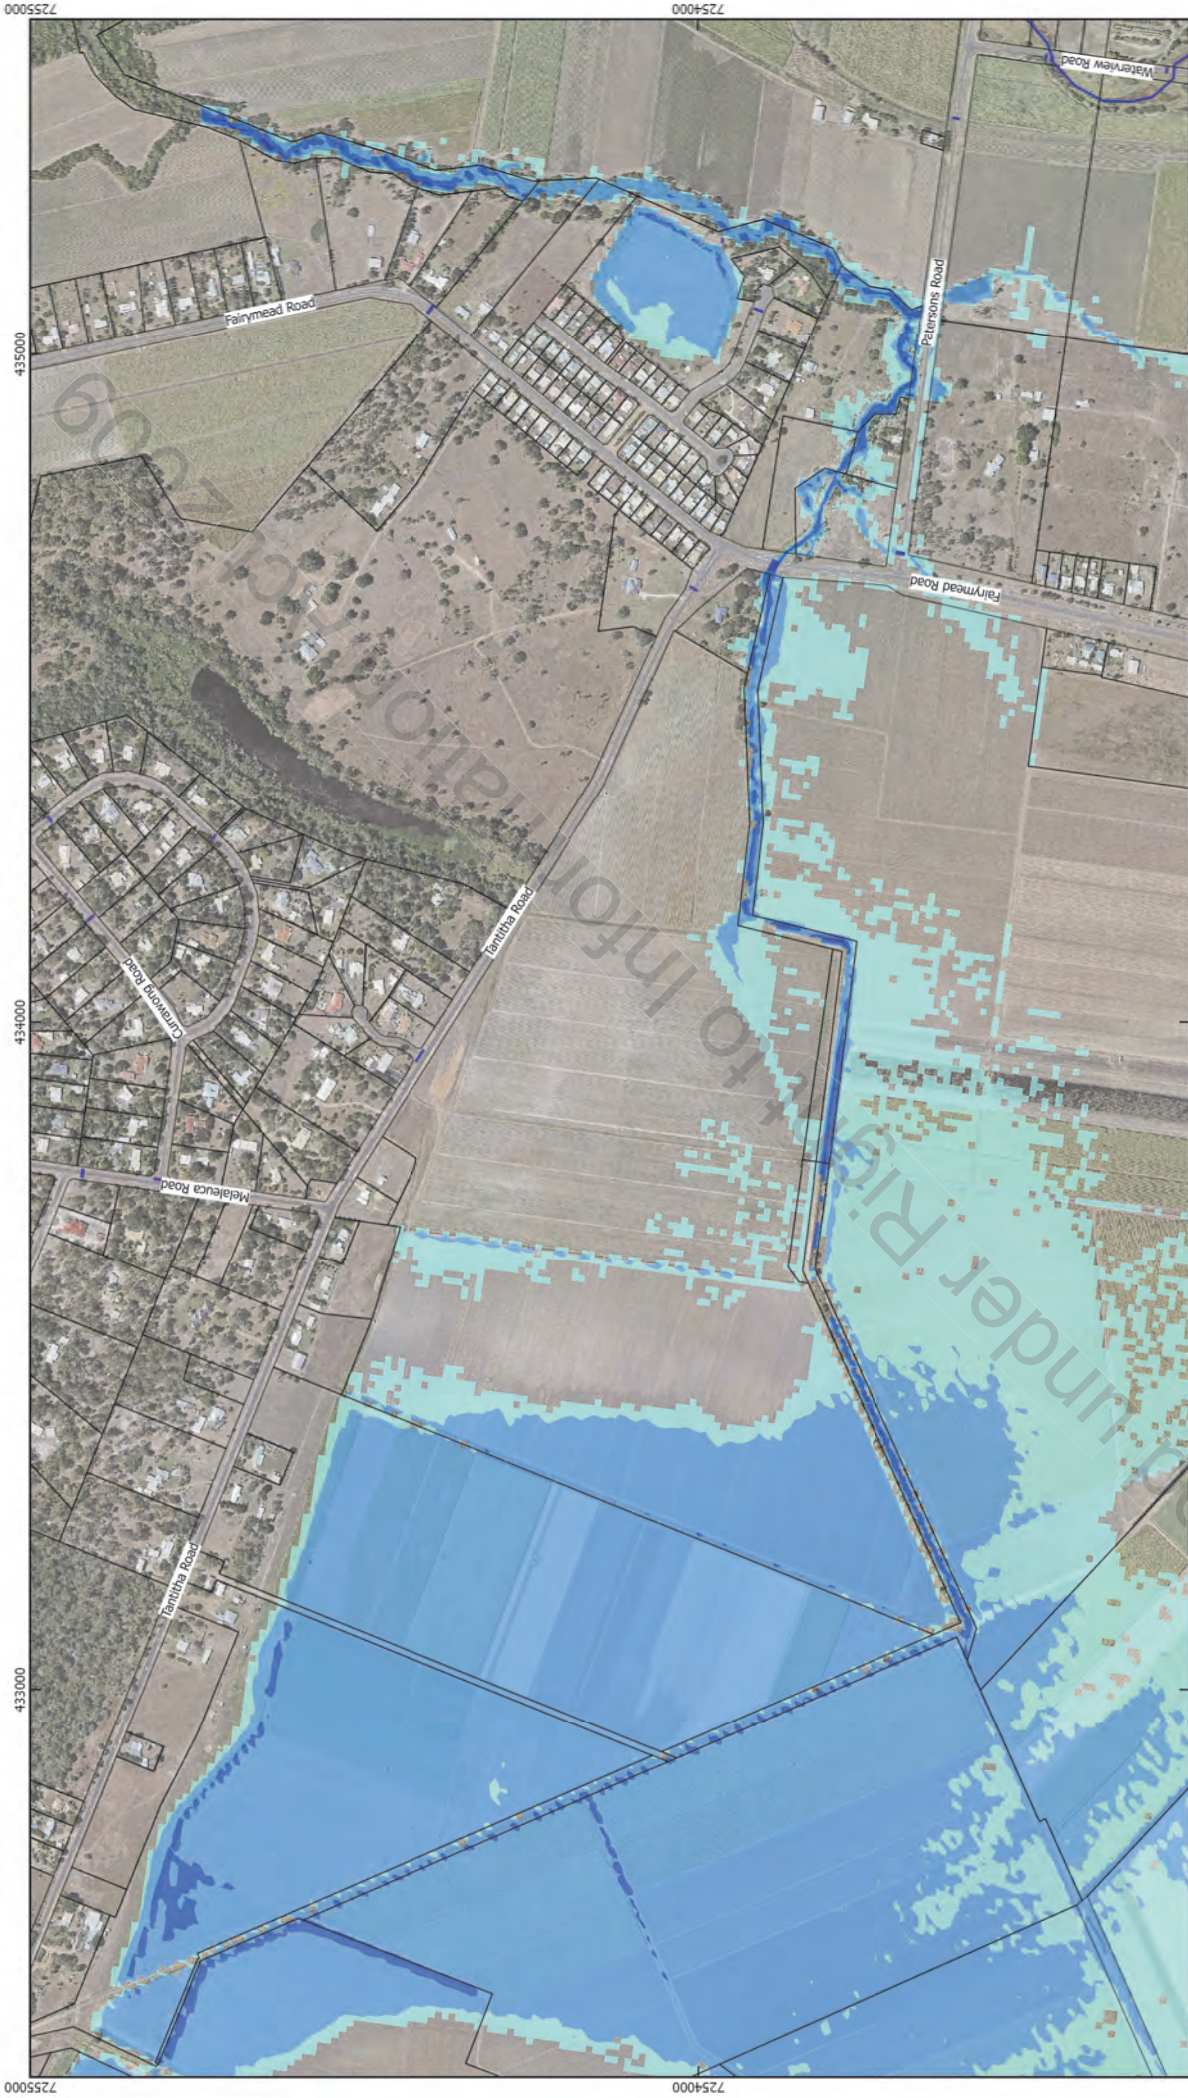
Hydraulic mapping results of the existing condition for each of the design storms are shown in the attached Figures B-1, B-2, C-1, C-2, D-1 and D-2. These figures show the maximum flood depth and the depth 24 hours after the beginning of the design storm (i.e. 18 hours following the conclusion of a 6 hour storm event).

ISD3080.2018 - Tantitha Creek
Drainage Improvements
Existing Condition - 0.5EY (Q2)
Depth at 24hr
Figure B-2

- In the 0.5 EY (2 Year ARI or Q2), 0.2 EY (5 Year ARI or Q5) and the 10% AEP (10 Year ARI or Q10) design storm events, the majority of No. 177 Tantitha Road is inundated by water greater than 300mm deep; and
- There is minimal difference between the maximum and 24 hour flood depth maps, indicating slow drainage from the Tantitha Creek floodplain.

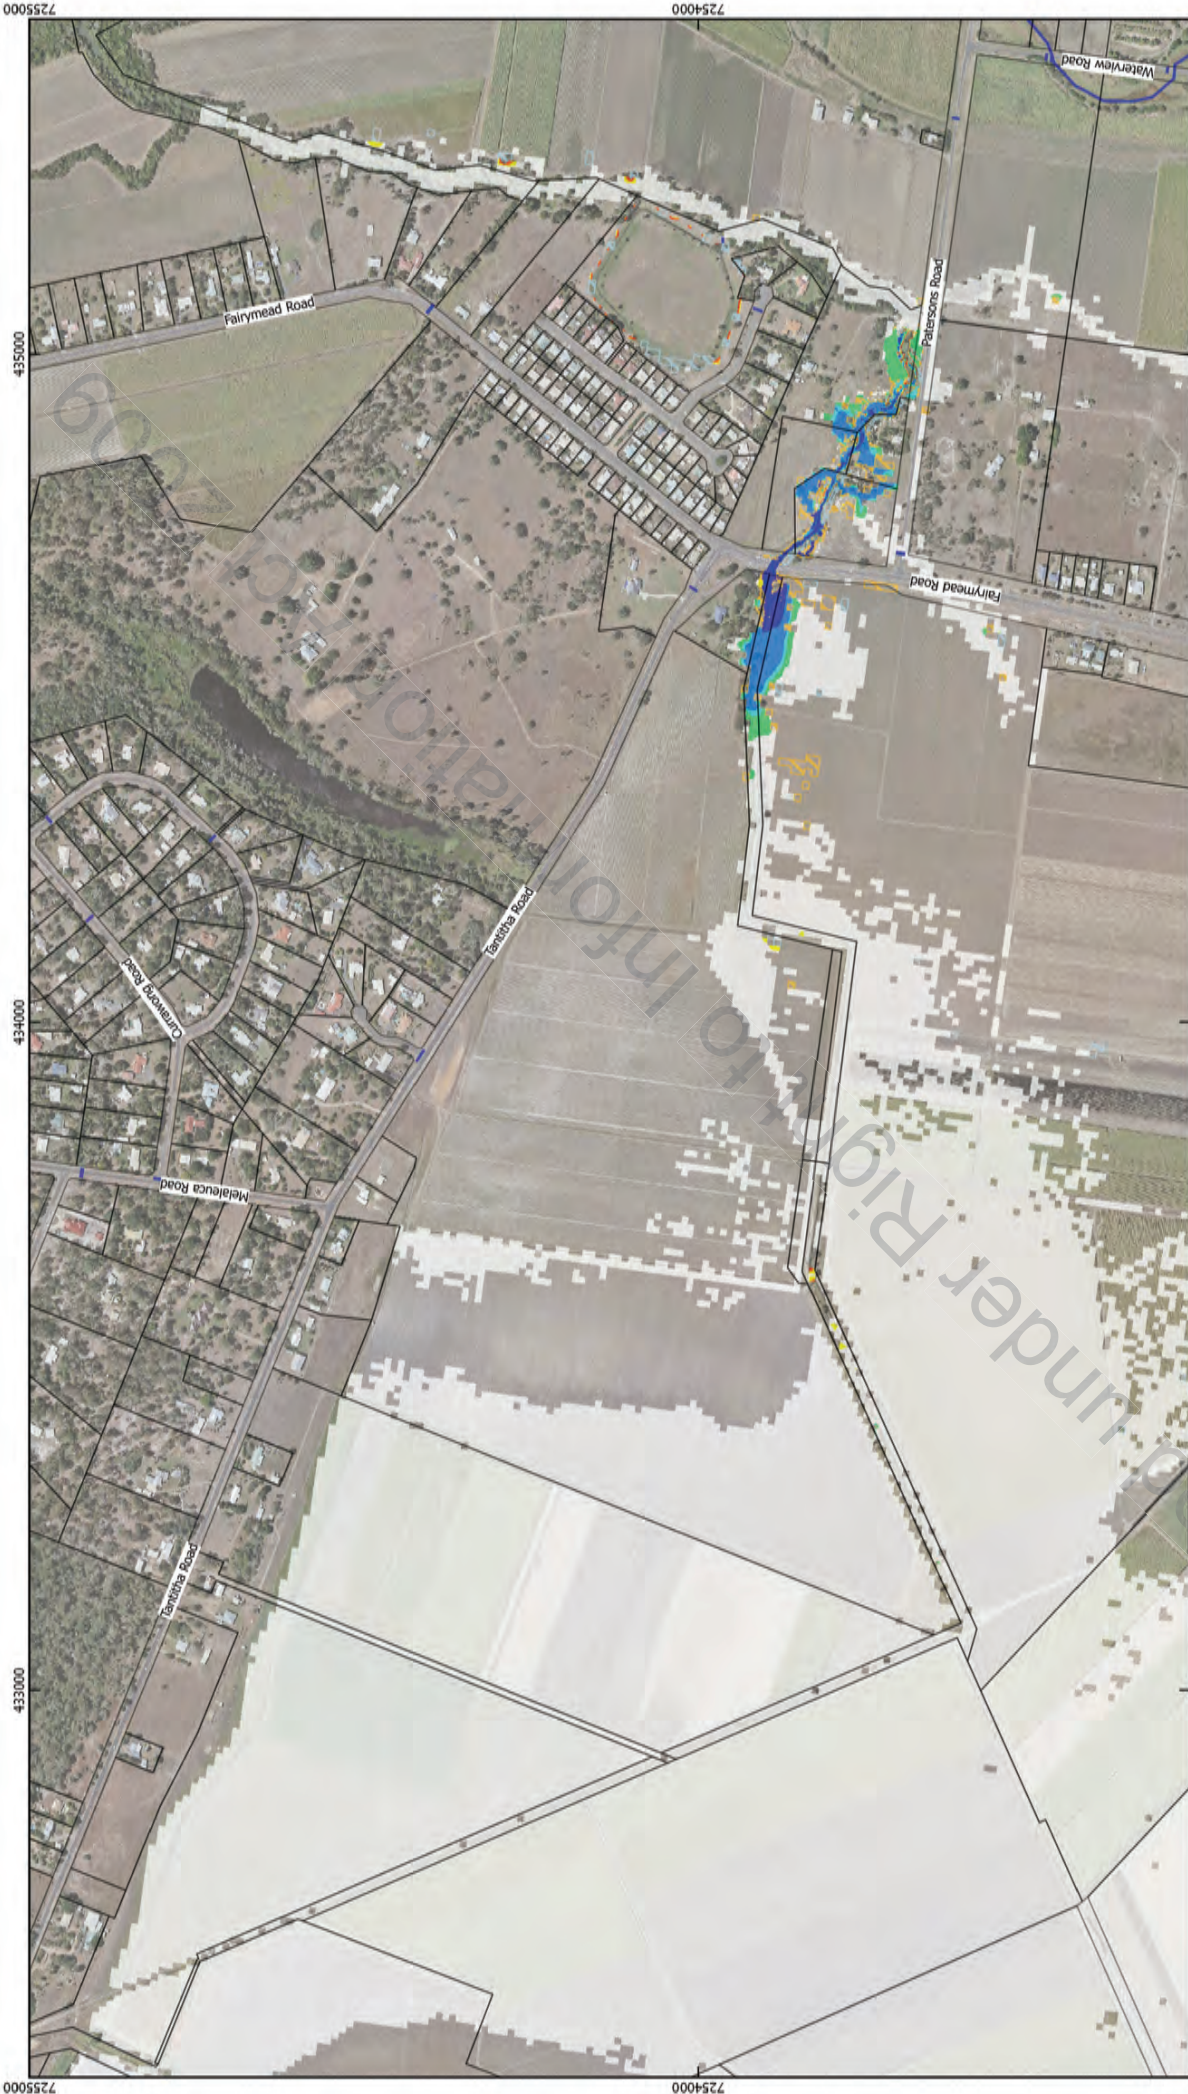
Hydraulic mapping results (change in depth 24hrs after the beginning of the design storm) for Option 1 are shown in the attached Figures B-3, C-3 and D-3 for the 0.5 EY (2 Year ARI or Q2), 0.2 EY (5 Year ARI or Q5) and the 10% AEP (10 Year ARI or Q10) design storm events respectively.

ISD3080.2018 - Tantitha Creek
Drainage Improvements
Option 1 - 0.5EY (Q2)
Change in Depth at 24hrs
Figure B-3

The results indicate that clearing of overgrown vegetation and widening of the open drain provides minimal benefits for property owners upstream of Fairymead Road. Minor reductions in water level are observed 18 hours after the conclusion of the design storm (i.e. 24 hours from the beginning) but are limited to within approximately 500m of the major culverts at Fairymead Road. The water level comparison (Appendix A) indicates almost no difference in the water level over time within No. 177 Tantitha Road for all modelled storm events. Clearing and widening of the downstream open drain therefore has a very limited effect on the time of inundation and free draining capacity of the upstream properties within the floodplain.

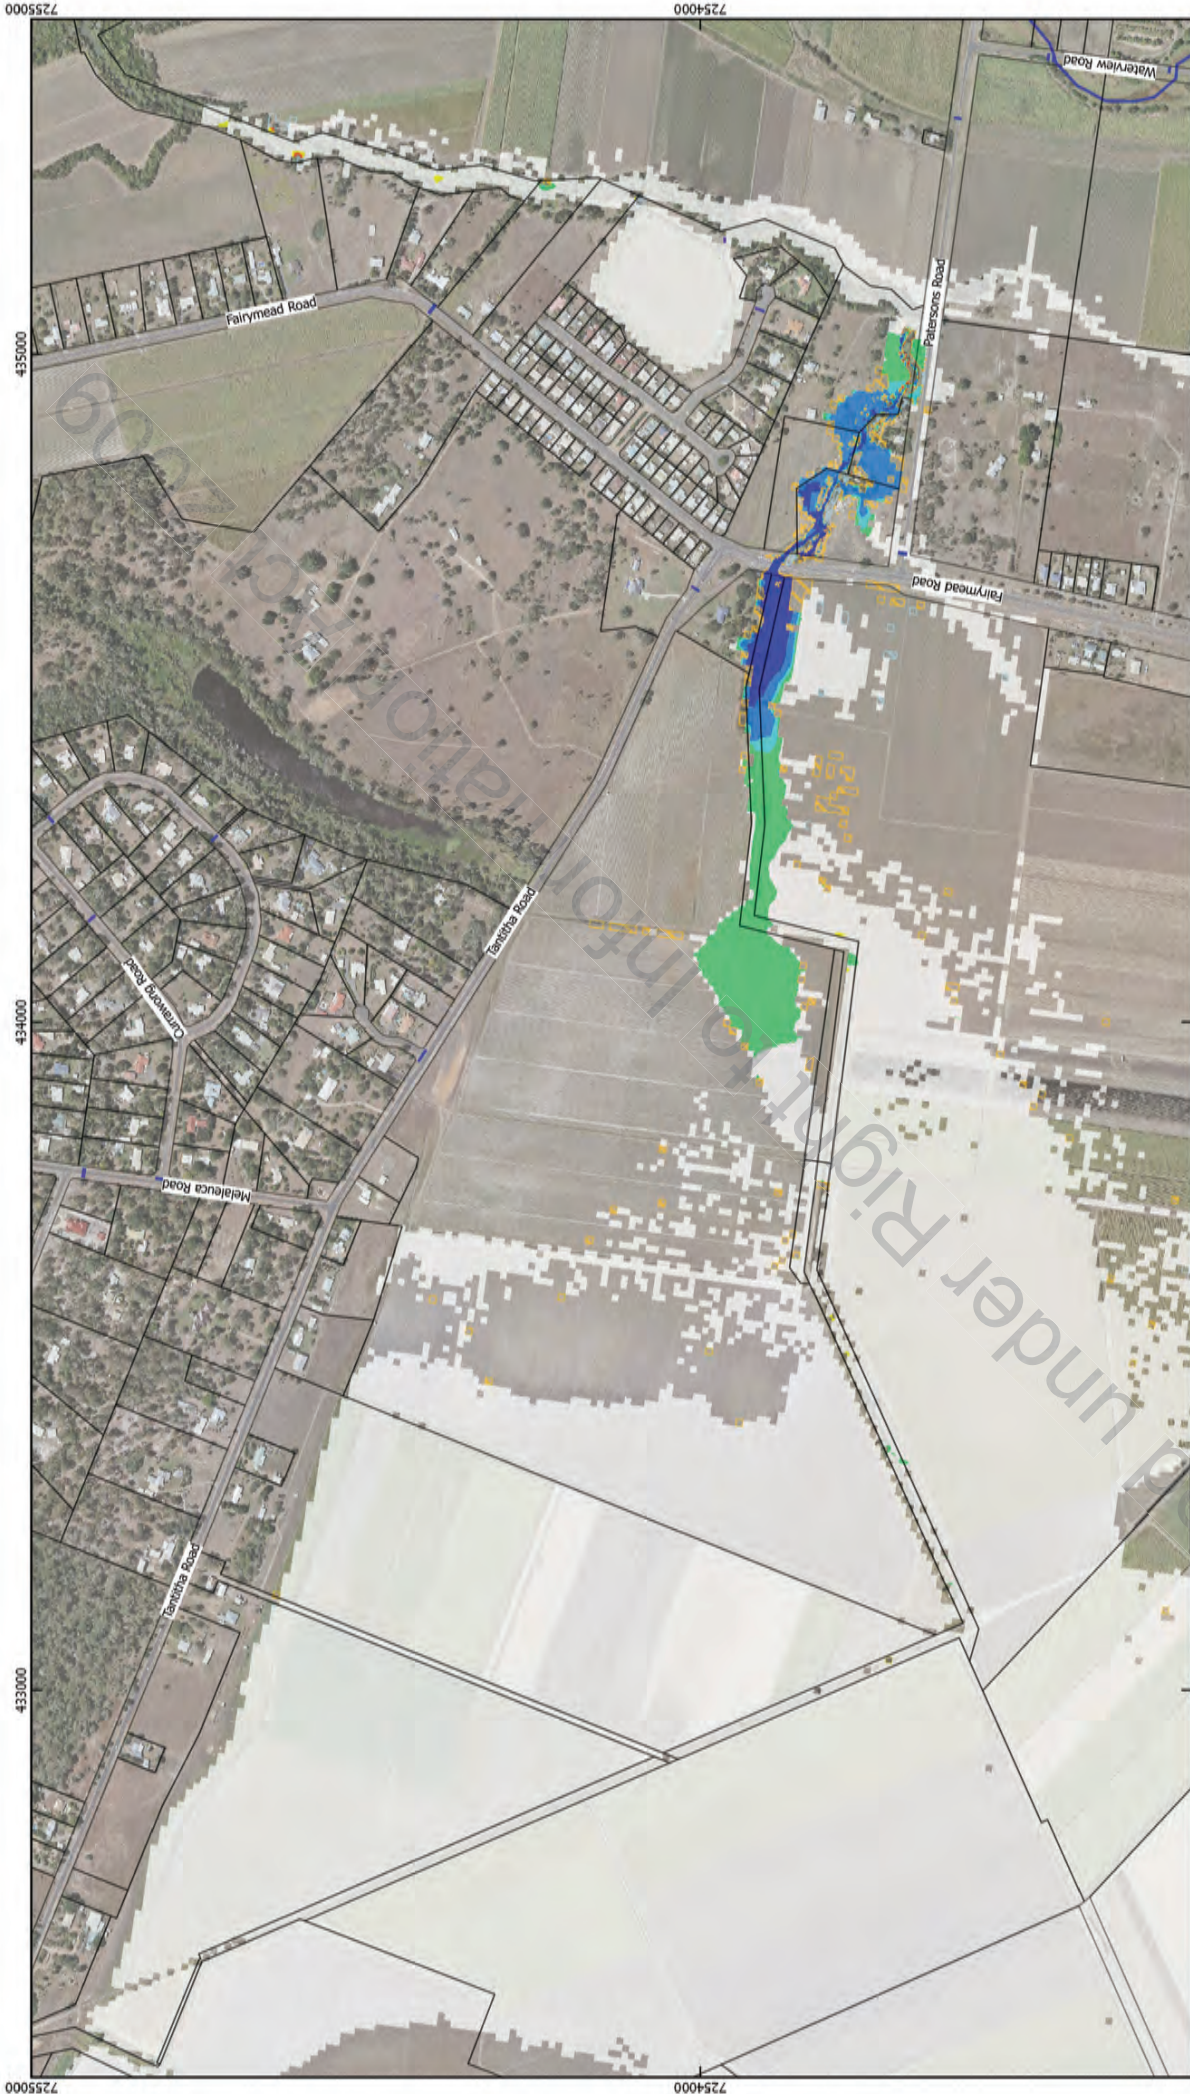
ISD3080.2018 - Tantiha Creek
Drainage Improvements
Option 1 - 0.2EY (Q5)
Change in Depth at 24hrs
Figure C-3

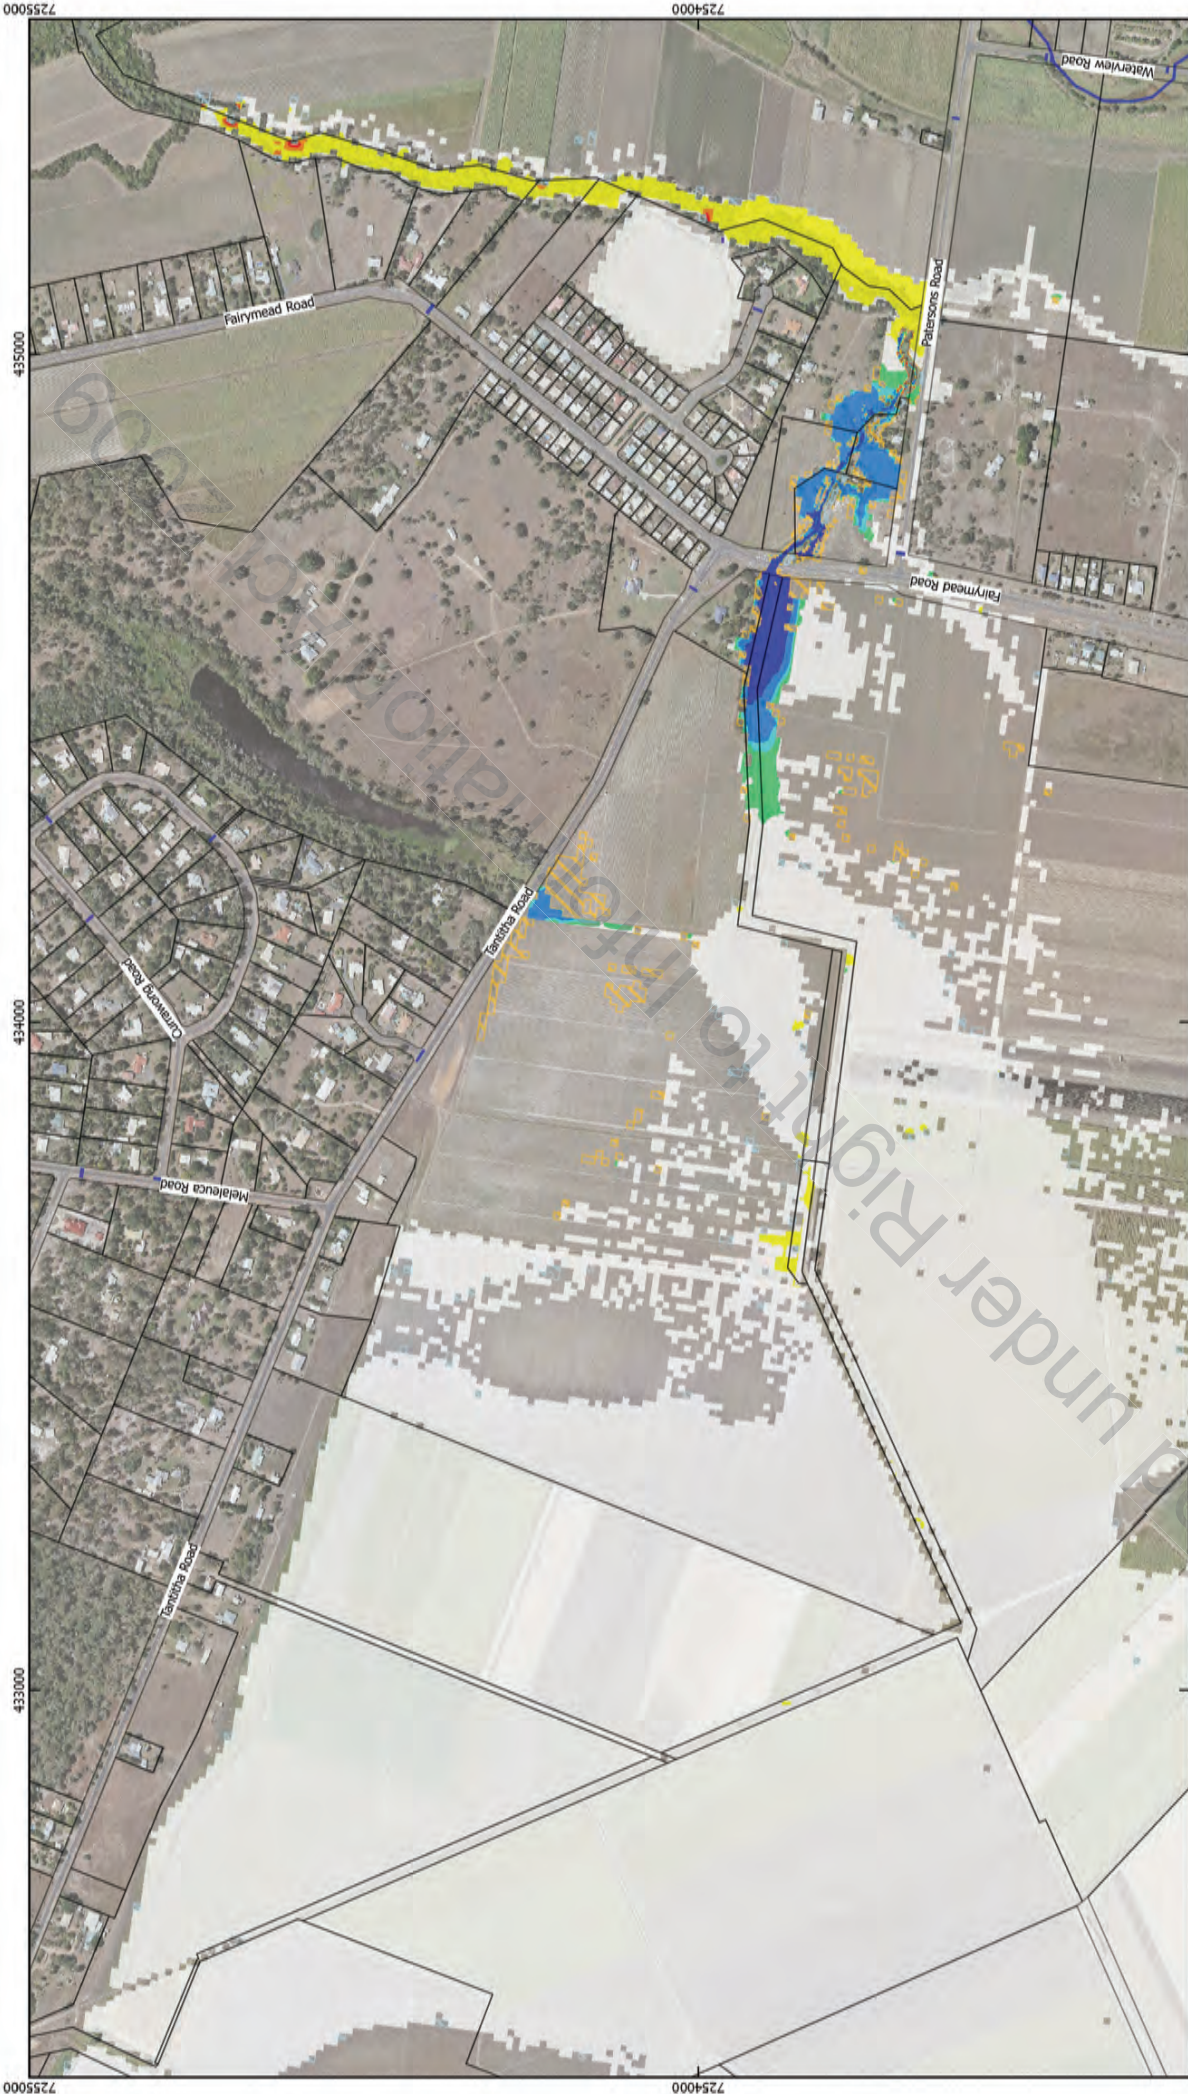
Option 1 - 10% AEP
Change in Depth at 24hrs
Figure D-3

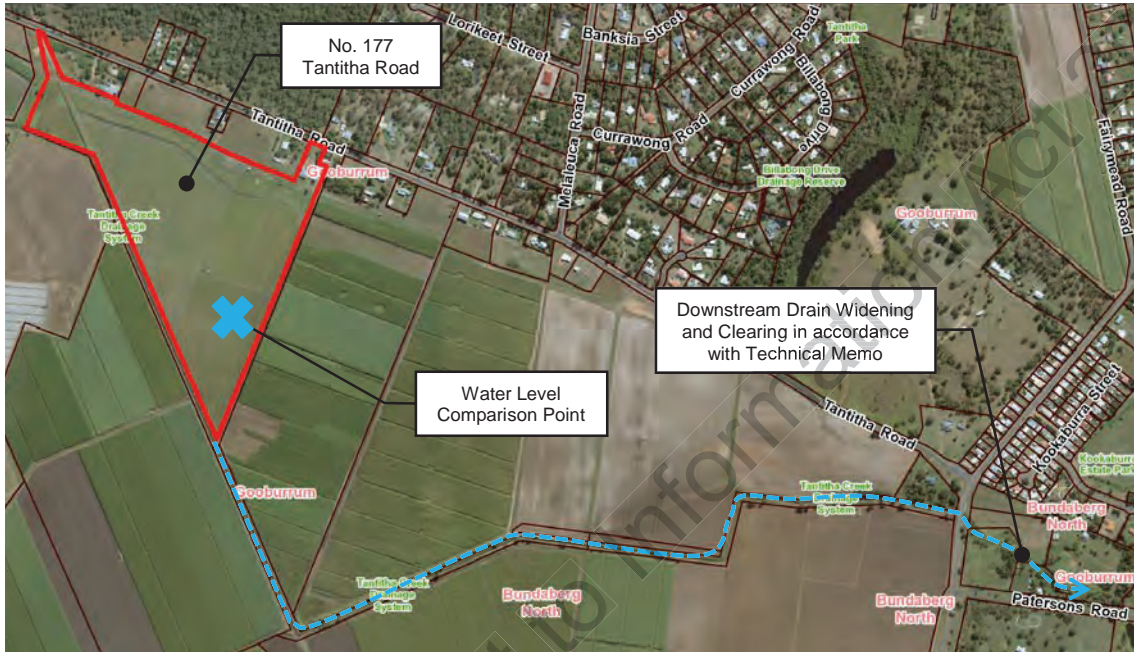
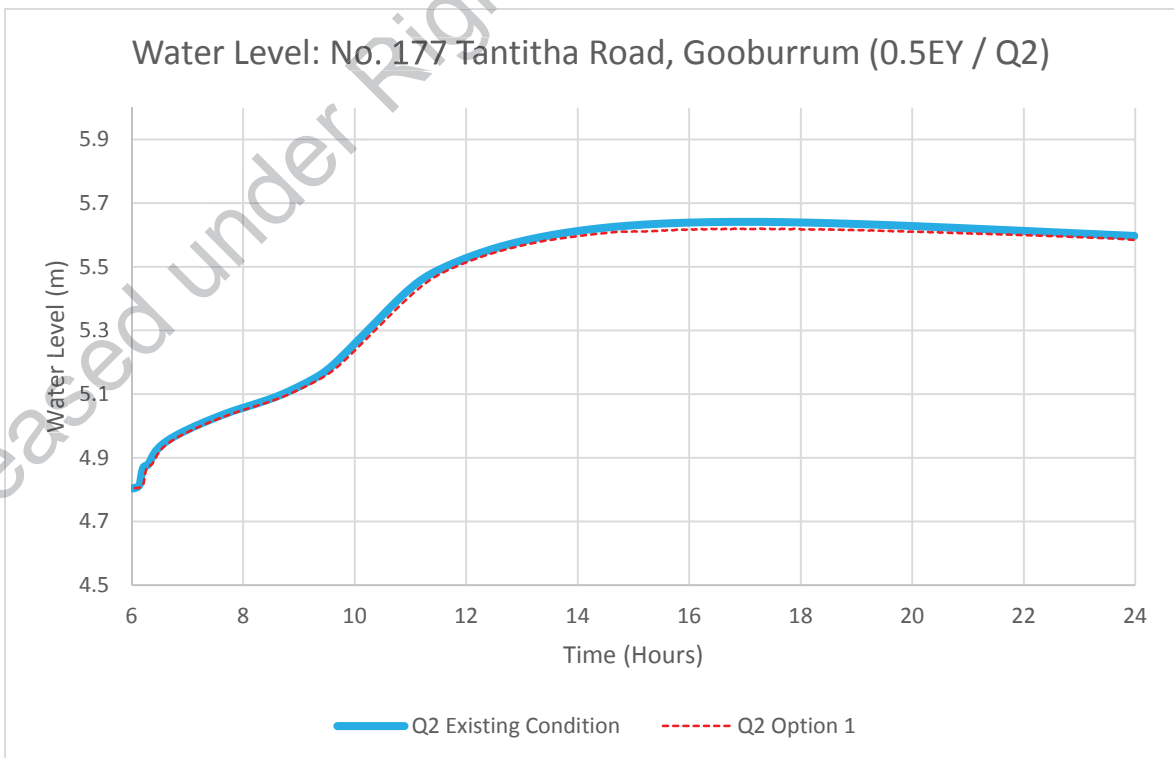
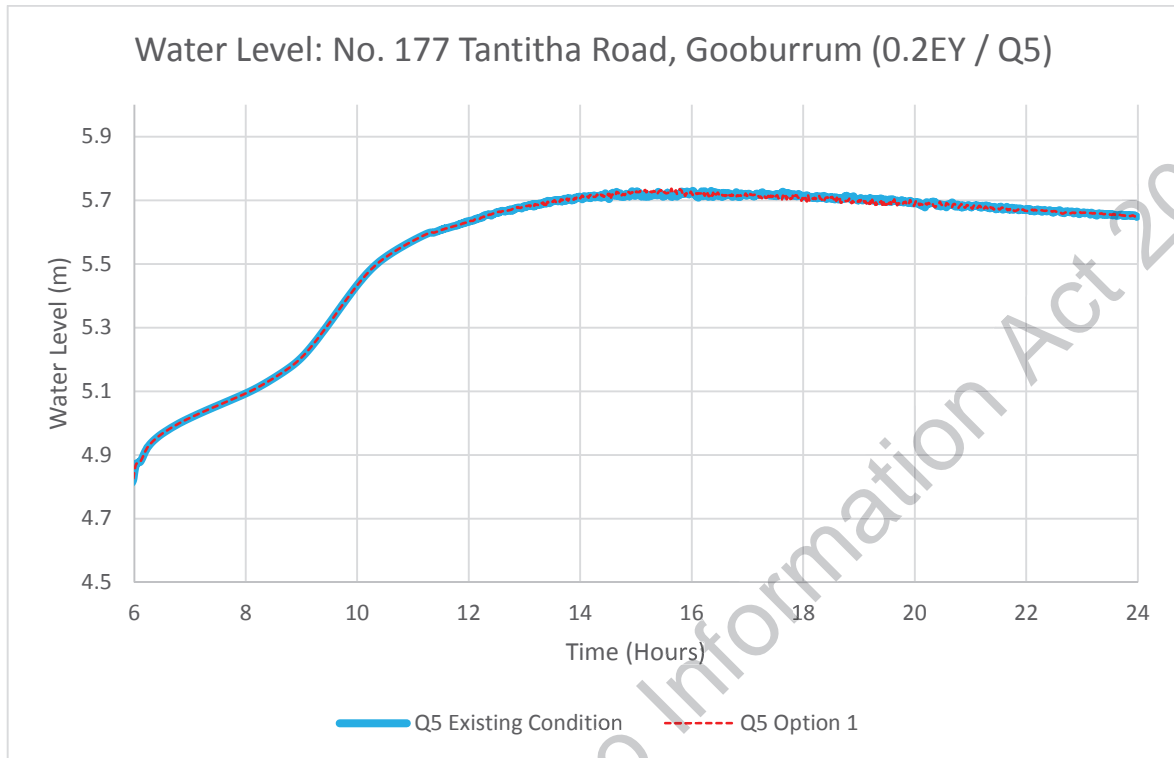
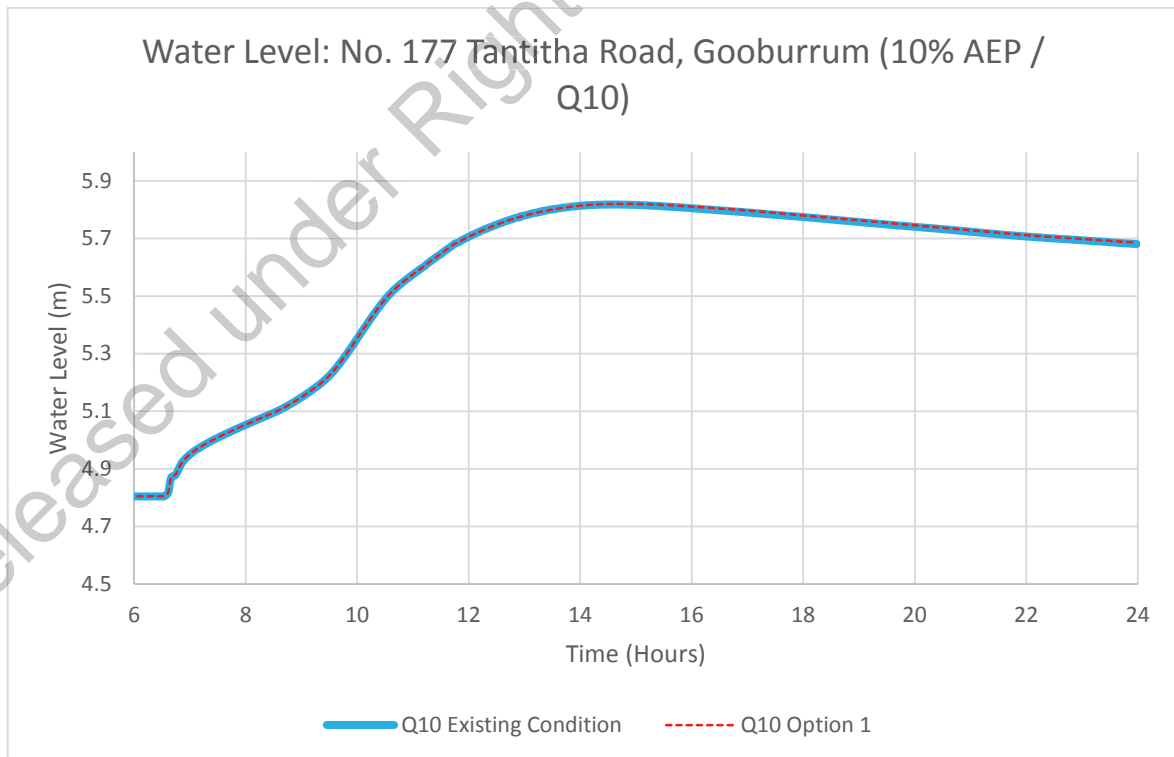
A water level comparison within No. 177 Tantitha Road is also included in attached Appendix A showing the existing condition water level and the water level due to the proposed clearing and drain widening (Option 1).

Appendix A: Water Level Comparison: No. 177 Tantitha Road, Gooburrum
