Trail Development Plan

Bundaberg Gin Gin Rail Trail

January 2019

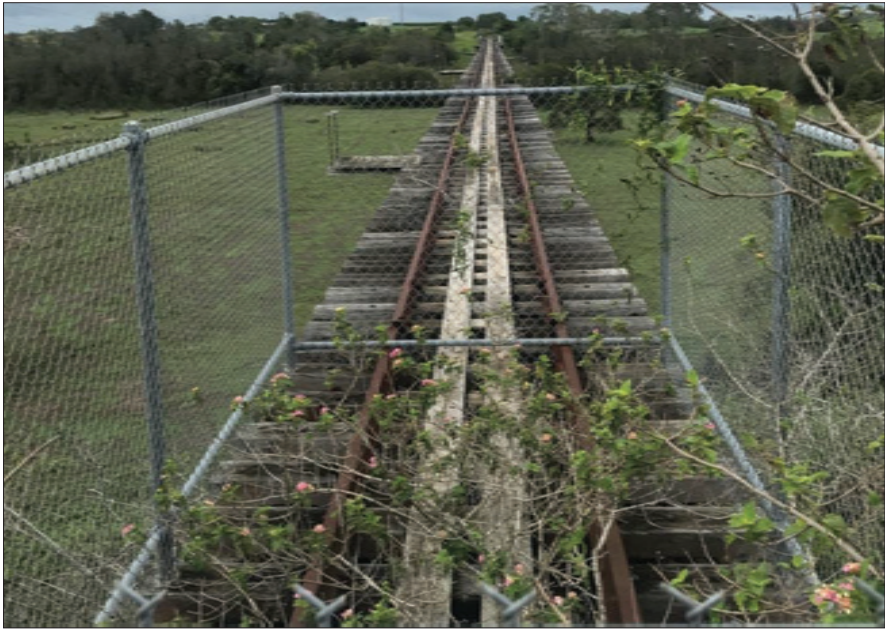
Figure 2-3: View on top of the bridge from Abutment 2. The transoms (rail ties) remain intact along with the railway line and the existing features such as the emergency bays (absent of hand rails on two sides in each case) off the side of the bridge.

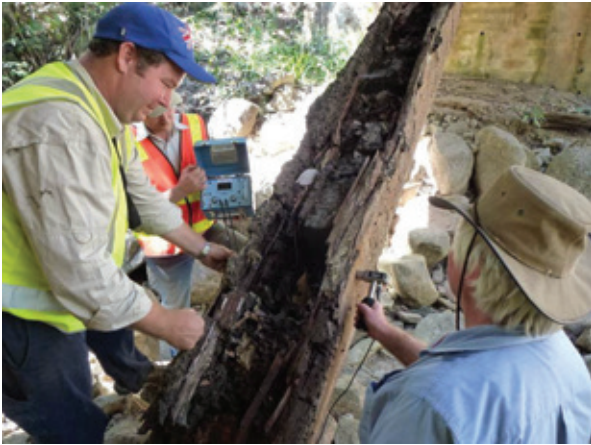
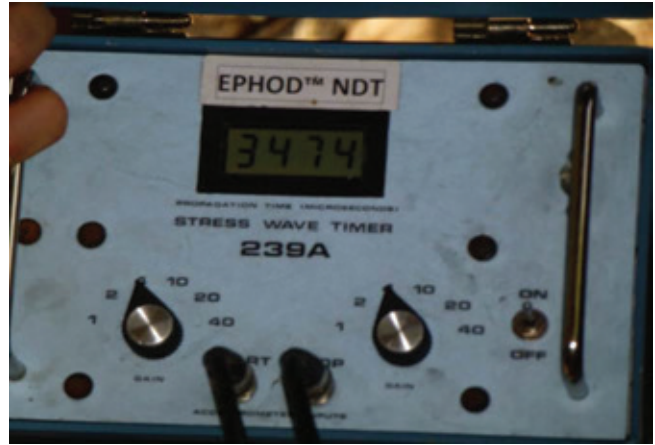
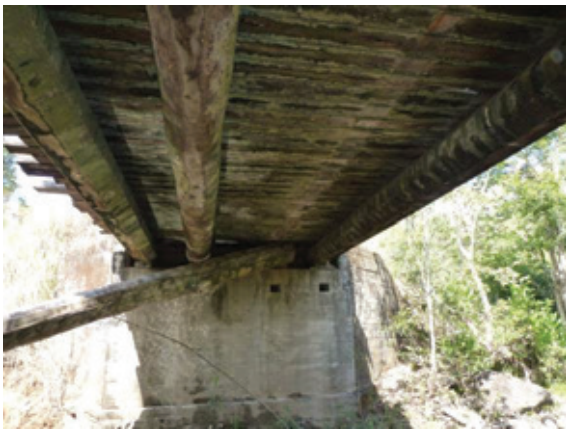
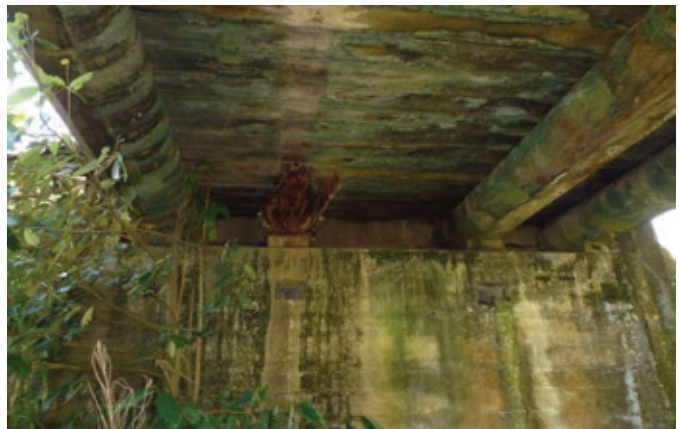
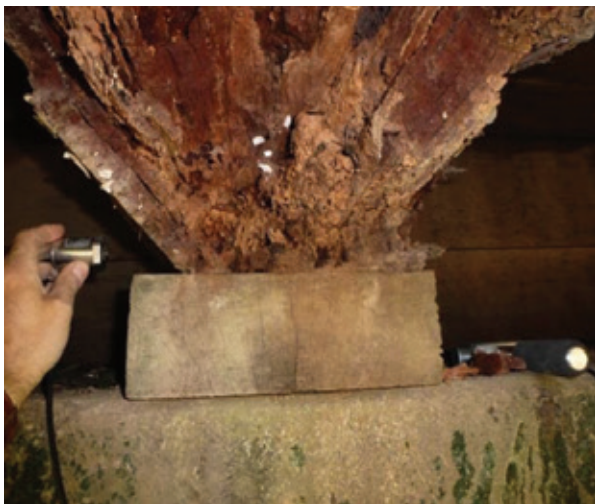
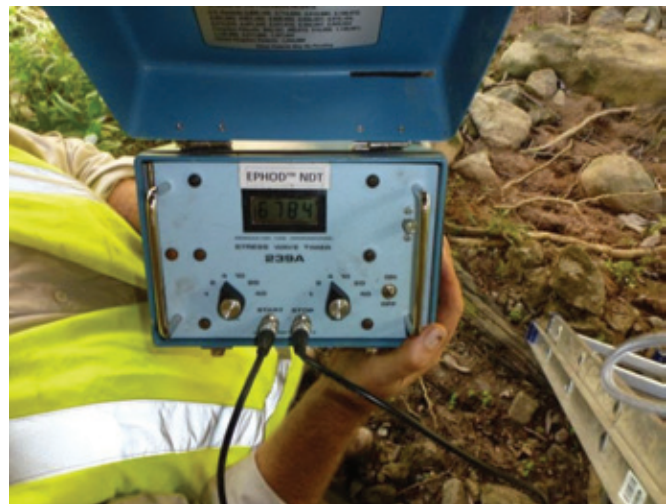
This rating was based from a small sample size of NDT field data collected and it is highly recommended to conduct a detailed inspection of the entire bridge. See **Figure 6-1** and **Appendix A** for more detail about this technology. This will gain a higher level of accuracy for the recommended repair options listed and costed in **Section 5**.

Figure 6-1: Photos showing global failure of a timber log girders. Both failures were caused by advanced decay in the ends of the girders and transverse shear failures. The primary cause of this decay was due to vertical fasteners. These failures were found in elements with SWT values in the 3k μ s (photos a. above) to 6k μ s range (photos b. below). Typically similar bending extreme tensile fibre failures in log girders occur in zones of decay where there are over 2k μ s SWT values. Similarly if vast portions of the log girder have SWT values over 3k μ s the failures may occur.

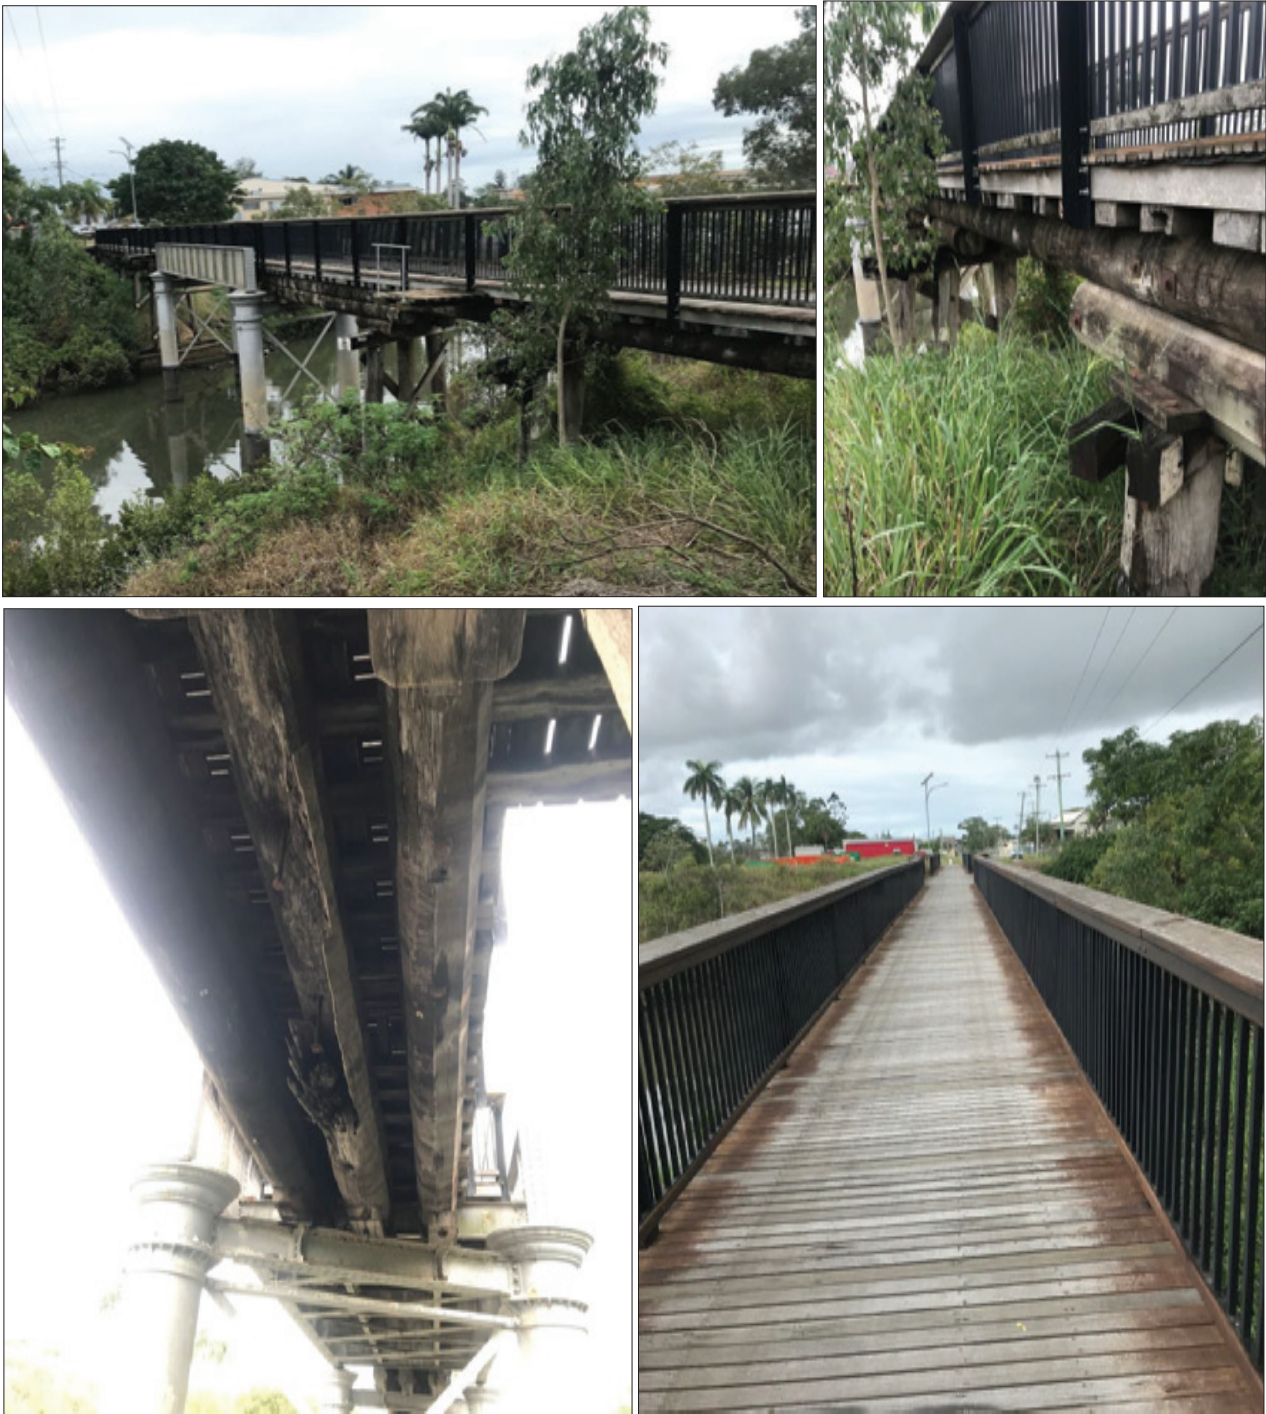
Figure 6-2: The above photo series demonstrates an Option 1 type of refurbishment (build off existing railway bridge) used for the construction of a pedestrian bridge along the same railway line as Splitters Creek Bridge and is located just off Quay Street on the North-East outskirts of Bundaberg CDB. The existing railway bridge was left un-touched and a new hardwood deck system with handrails was installed. Six 100mm x 250mm timber joists were placed on top of the existing transoms (rail ties) with a 38-50mm thick hardwood deck installed on top. This option will likely be the lowest cost but also carries the shortest expected lifespan. As seen in the bottom left photo above, one of the girders has failed and fallen out creating a ‘weak’ point along the bridge. Due to a high residual capacity of timber and the continuous joists, a complete failure of the bridge (span) hasn’t occurred yet but is only a matter of time unless extensive maintenance is undertaken.

See Table 5-1 and the cost estimate below for more details of this option. Also refer to **Figure 6-2** for a photo narrative of this type of refurbishment used for a similar railway bridge along the same railway line closer to the township of Bundaberg. **Figure 6-5** shows similar type of fixes using high strength fibres and can be see below.

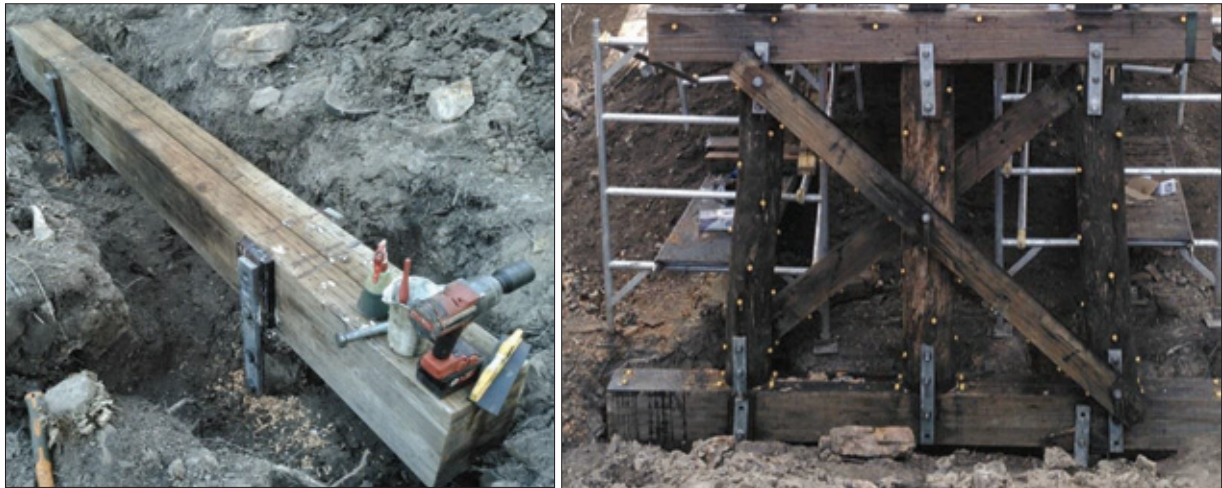
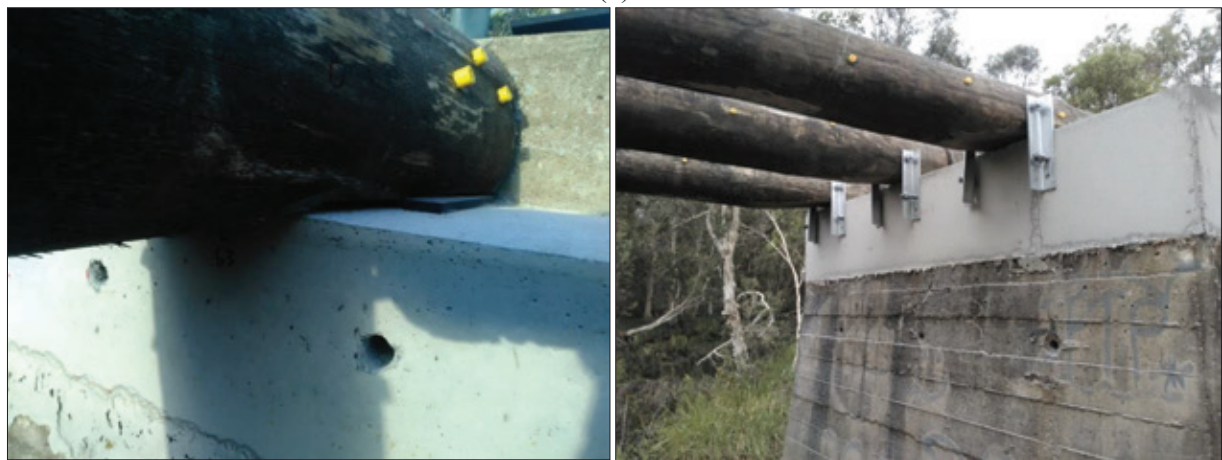
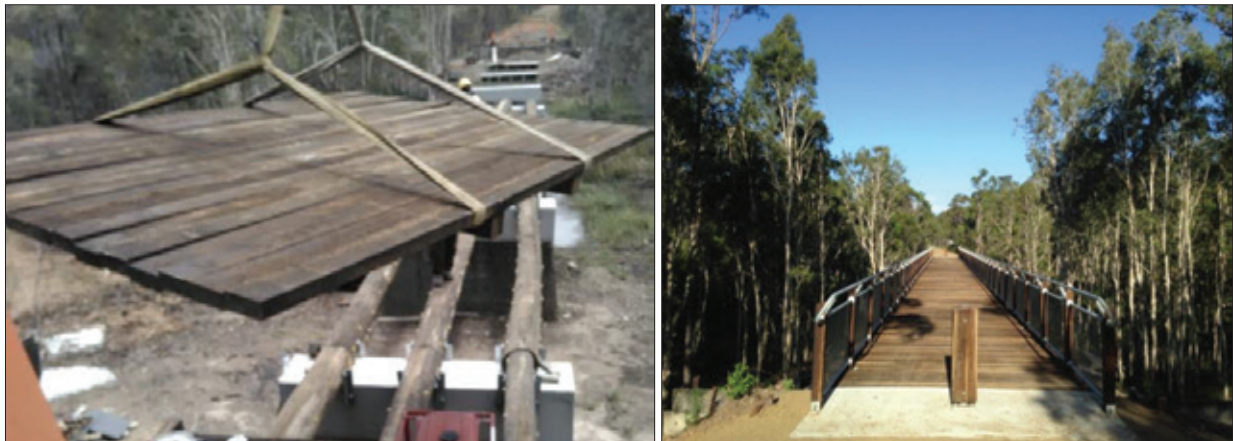
Figure 6-3: The above photo series demonstrates Option 2 type of fix (hardwood) used for the construction of two Mary to Bay Rail Trail Bridges. Seen above in photo (a) is the construction of a frame bent using an intermediate cap which was installed on top of the existing pile stubs. This allowed the hardwood posts, cross bracing and cap to be installed at the correct reference height. Also note the yellow plugs that indicate that Decaystop® rods have been installed. Photo (b) shows the girders being installed using a horizontal connection system and a rubber liner between the timber girder and concrete pier. In photo (c) the pre-panelised deck is installed along with the modulus handrail and cycle rail system.

See Table 5-2 and the cost estimate below for more details of this option. Also refer to **Figure 6-3** for a photo narrative of this type of refurbishment used for a rail trail bridge along the Mary to Bay Rail Trail in the Fraser Coast Region.

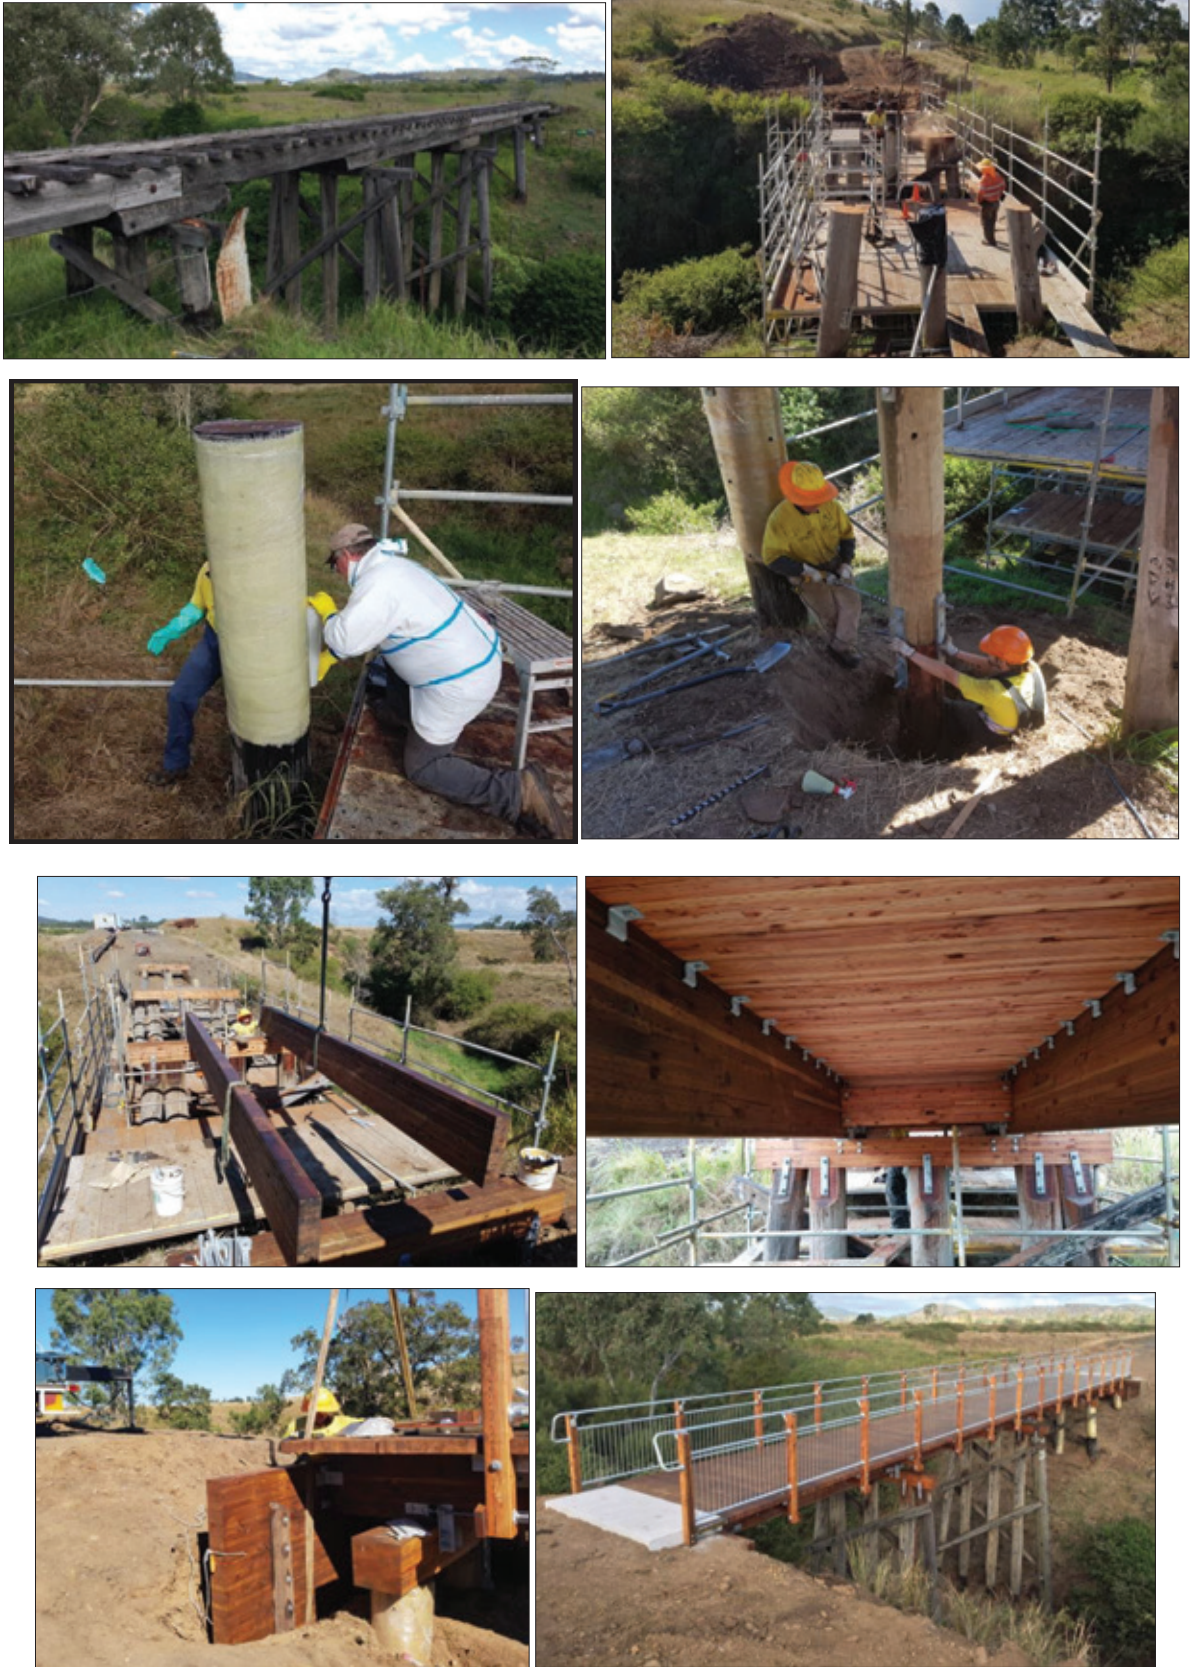
Figure 6-4: The photo series above demonstrates Option 3 type of fix that was done for Jimmy Gully Bridge along the BVRT. The existing poor condition superstructure was removed and the piles were repaired with high strength fibre or posted with new section. New glulam back wall, caps, girders and deck system was installed utilising a horizontal connection detail.

See Table 5-3 and the cost estimate below for more details of this option. Also refer to Figure 6-4 for a photo narrative of this type of refurbishment used for a rail trail bridge along the Brisbane Valley Rail Trail in the Somerset Regional Council district.
